Post Closure Residual Risk Assessment

Golden Cross Mine

12 August 2016
42039944/R 003/D

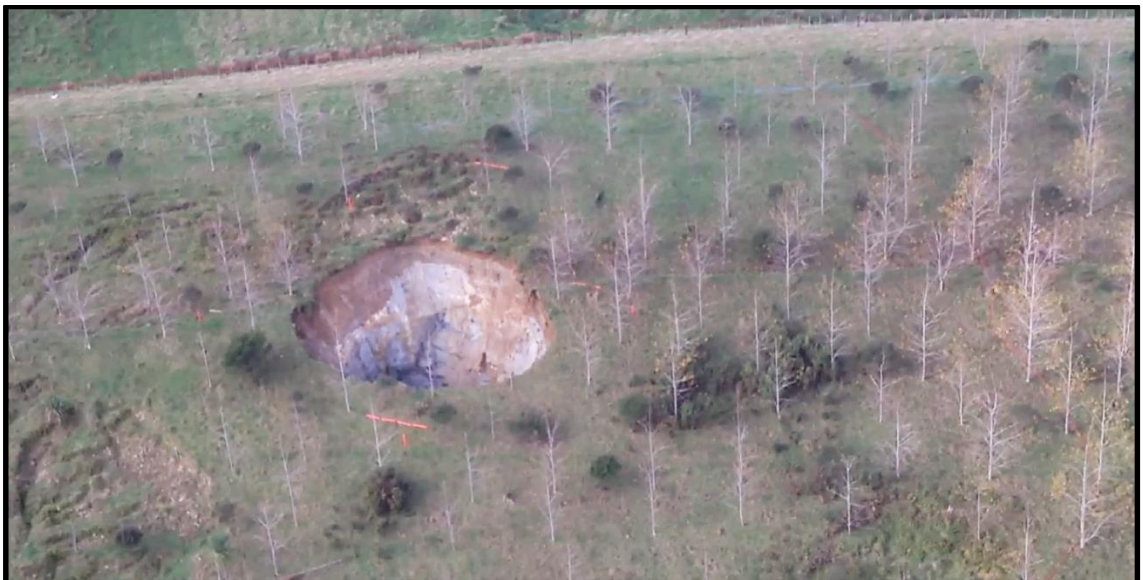
The sinkhole was initially described as approximately 20 m in diameter and 20 m deep. T&T staff visited the site on 14 and 20 June, and again on 26 July 2013 (see Figures 4-1 and 4-2). Over the course of these visits T&T observed that the sinkhole opening at the surface had enlarged in an upslope direction by 11.5m. Material from the upslope regression was backfilling the sinkhole and water was ponding on the top of the debris backfill (Figure 4-3). Reference pegs were installed around the sinkhole which were used for visual observation of changes and a safety fence was installed.

Figure 4-1 Aerial view of sinkhole 14 June 2013

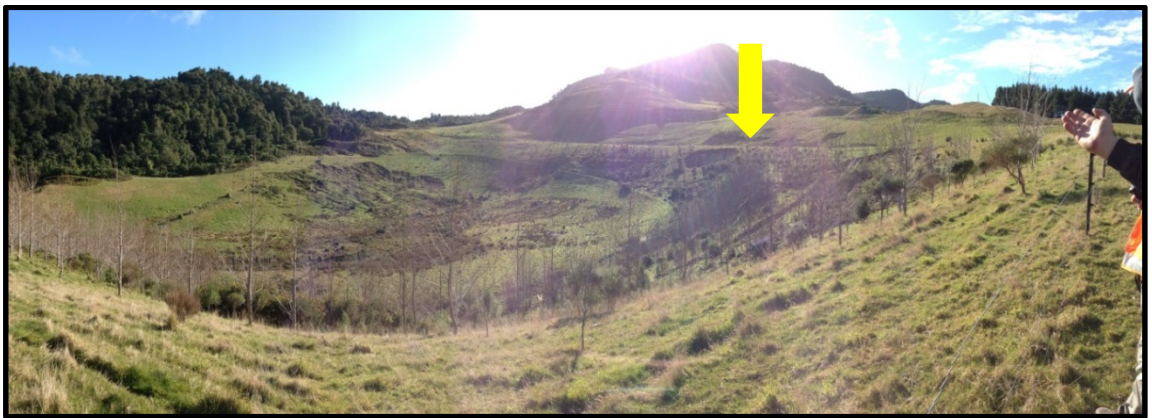
The scope of work for the revision of this risk assessment included a URS inspection of the site to view site conditions, including the sinkhole. This was undertaken on 24 July 2014. At this time the sinkhole was estimated to be about 40m in diameter and 20m deep and it was clear that the sinkhole had regressed further upslope. (See Figures 4-4 and 4-5). Comparison of 2013 and 2014 photography shows that the sinkhole has enlarged on the north, east and southern sides, however, the western margin appeared to be the same.

Figure 4-4 Open Pit Sinkhole development as of July 2014

URS noted, in 2014 that the sink hole had regressed upslope.

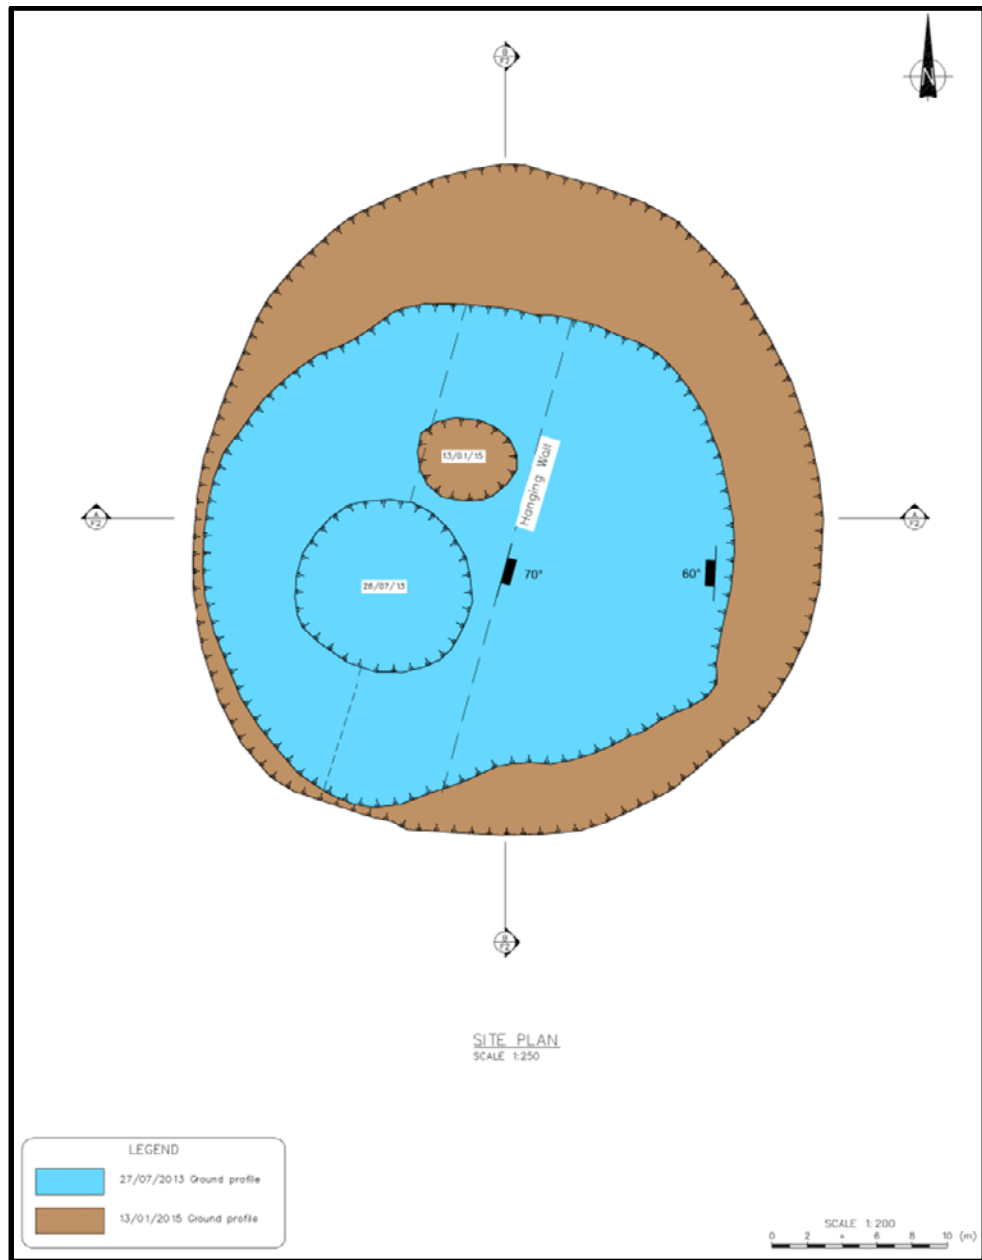
Figure 4-6 Sinkhole ground profile measurements (from T&T, 2015)

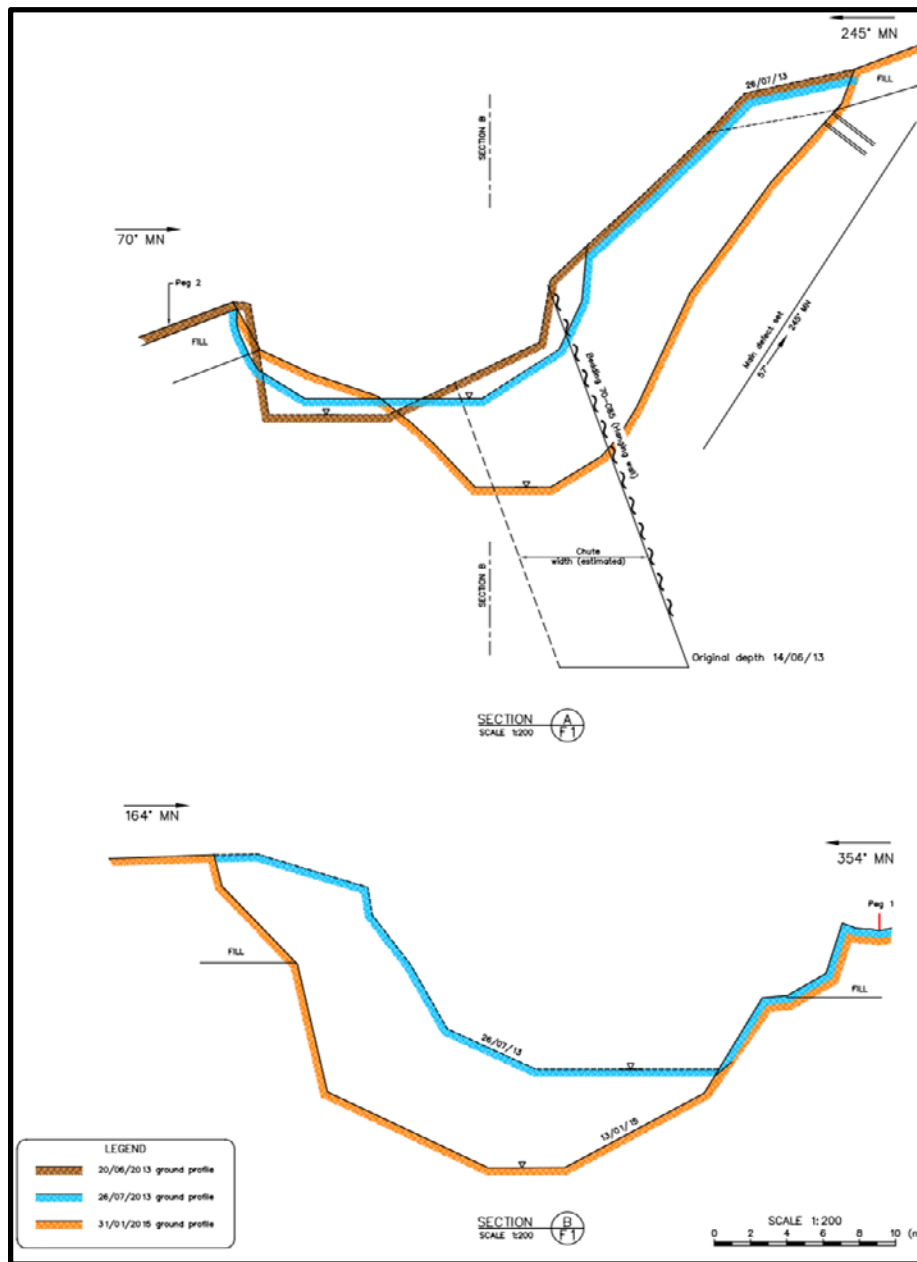
Figure 4-7 2015 Sinkhole Cross Sections (from T&T, 2015)

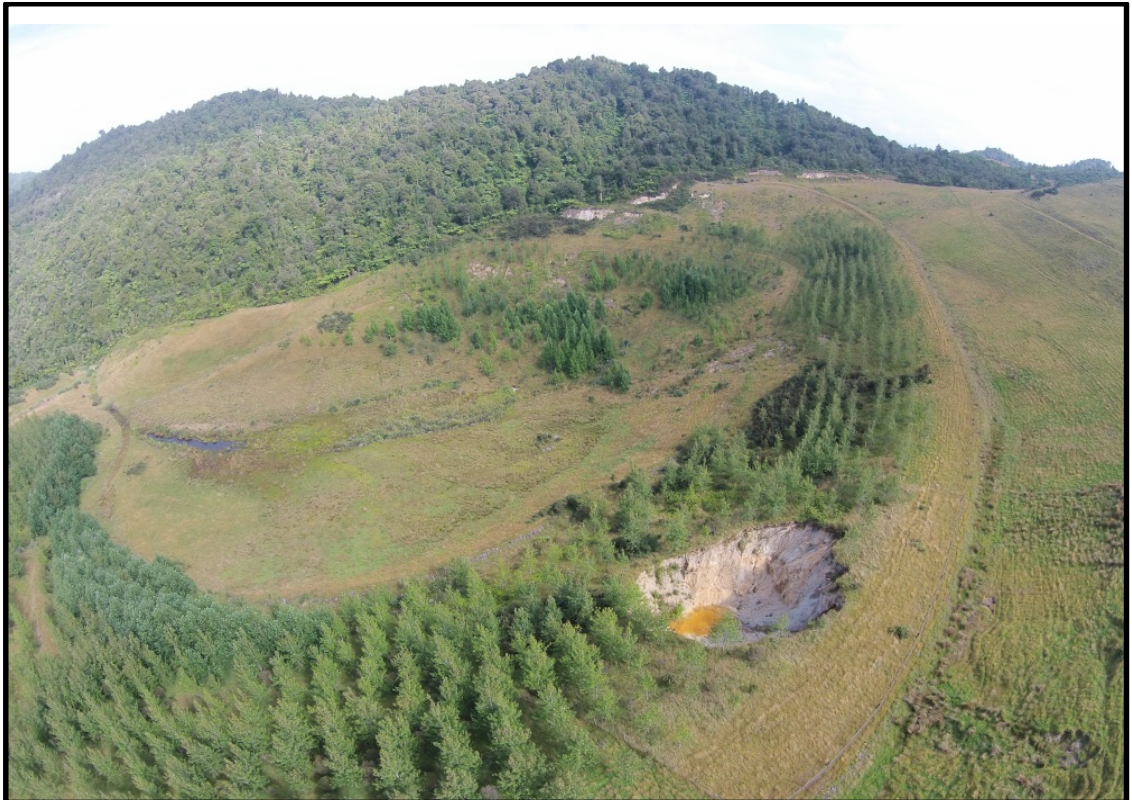
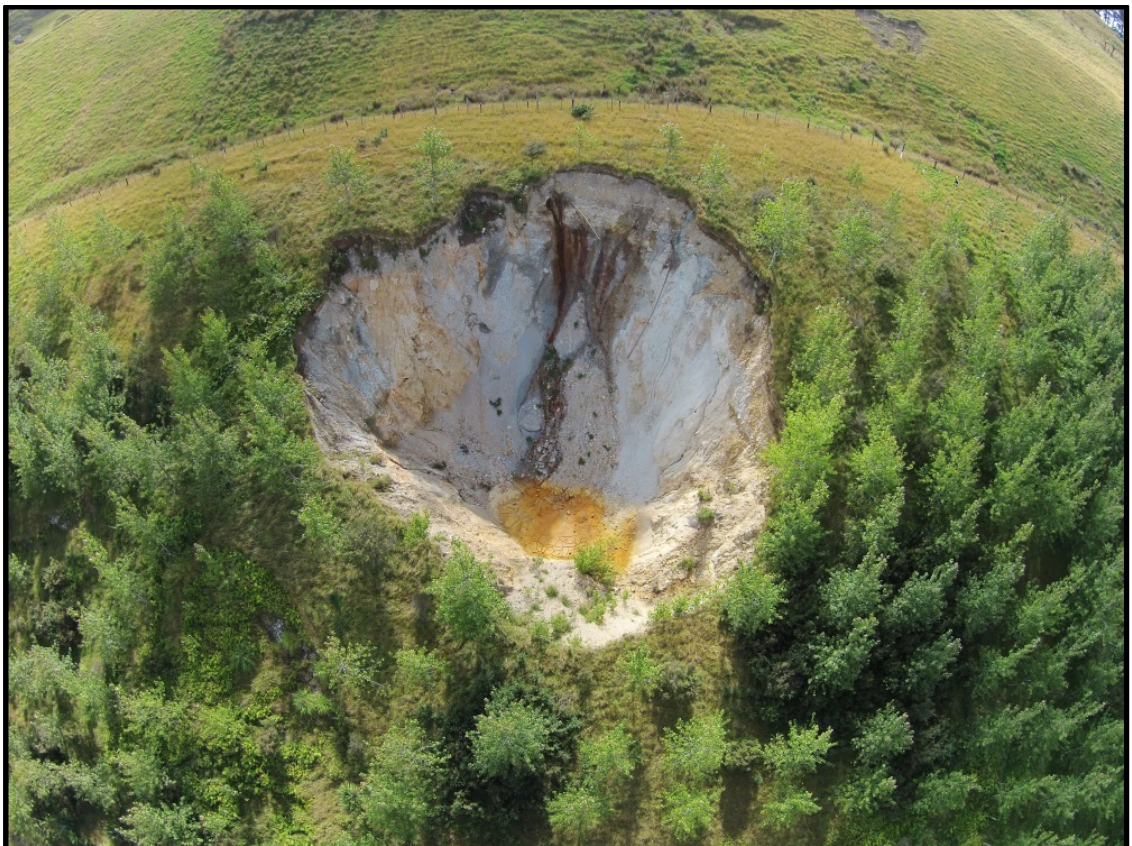
GCJV have amended the monitoring of the sinkhole size with the implementation of drone surveys from December 2015. Figure 4-8 presents the June 2016 aerial photograph of the sinkhole.

Figure 4-8 June 2015 sinkhole images from aerial survey drone

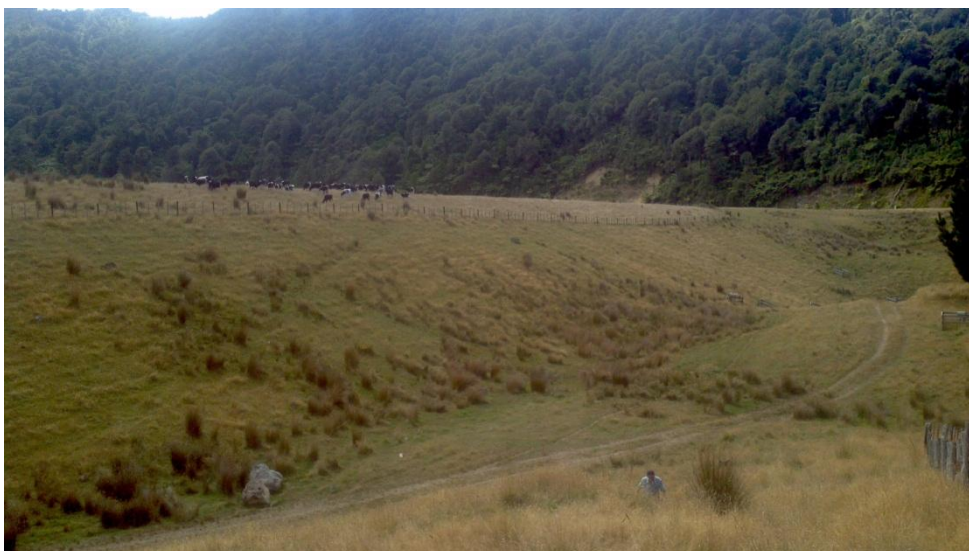
Of note were previously identified areas of concentrated seepage and erosion on the south-east facing slope of the Saddle Embankment. These areas are delineated by pockets of reeds ("Yorkshire fog grass") that prefer damp soil conditions. It was noted that the seepage areas were not currently active (dry), which suggest they are the result of prevailing weather conditions and poor drying due to the slope aspect as opposed to seepage from the tailings pond.

Photo 1: View of Saddle Embankment from Trig J. Note seepage and erosion areas defined by reed grass

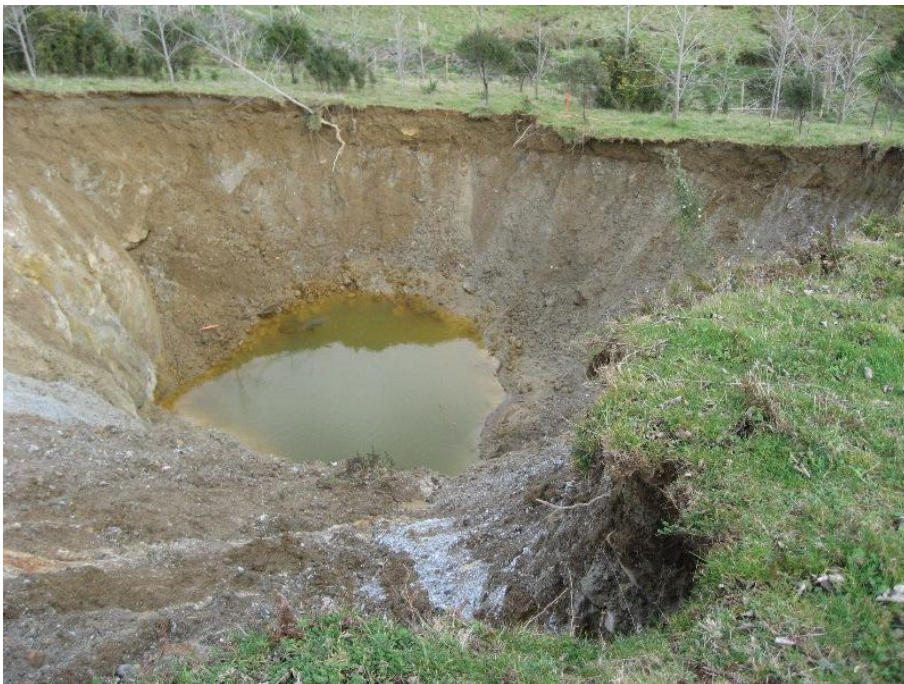
- The sink hole had regressed upslope 1.5m since the June 2013 visit. See Photograph 1 below.
- The fault zone was clearer than previous visits (due to material having been washed off the face) and the fault zone width was measured by hand held laser at 7m.
- Water was still ponded within the base of the sink hole, indicating that the top of the collapse shaft had been sealed off.
- There was shallow tension cracking within 2m of the edges of the sink hole opening indicating that that further small scale regression of the sides may be expected.
- An additional 5 monitoring pegs were installed and surveyed in by hand held GPS along the strike of the fault zone to assist with future monitoring as required.

Photograph 1: View of sink hole on 26 July 2013 from the upslope (east) side

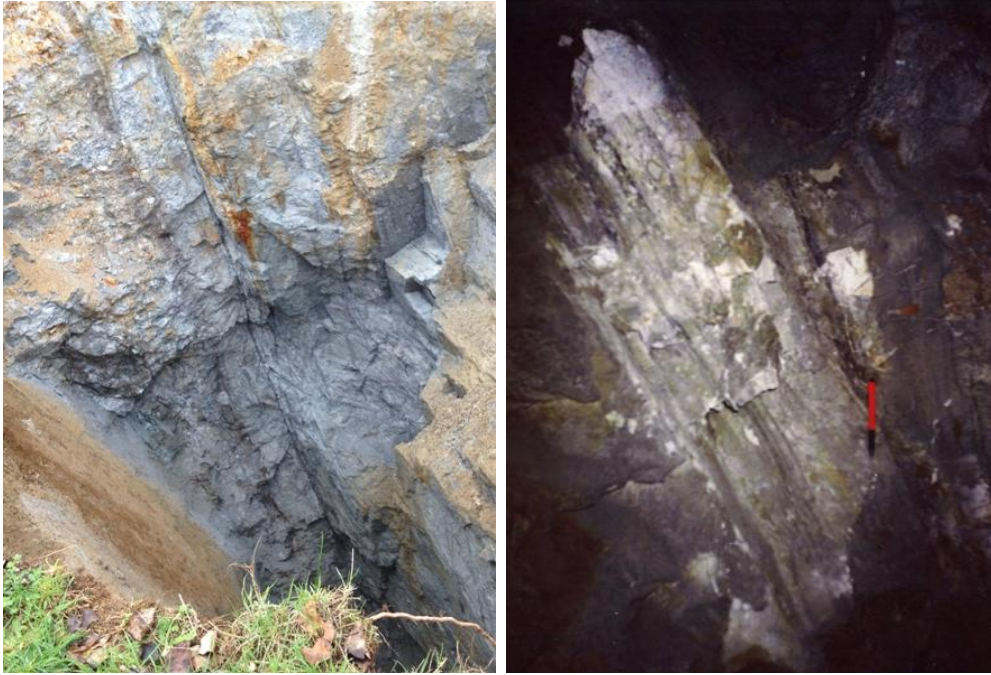
Photograph 2 below shows the fault zone dipping at approximately 70 degrees to the east as observed at the 14 June 2013 inspection. The dark lines close to the fault dip in Photograph 2 are identical to those shown on Figure 5 of the Rabone underground report (Ref.9) where they are described as carbonaceous horizons within the Tuff Marker Horizon.

Photograph 2(left): A photograph taken on 14 June 2013 indicating the faulted zone (includes the dark carbonaceous horizons) within the sink hole. Photograph 3 (right): Figure 5 from Rabone 1993 underground report which also includes the dark carbonaceous horizons.

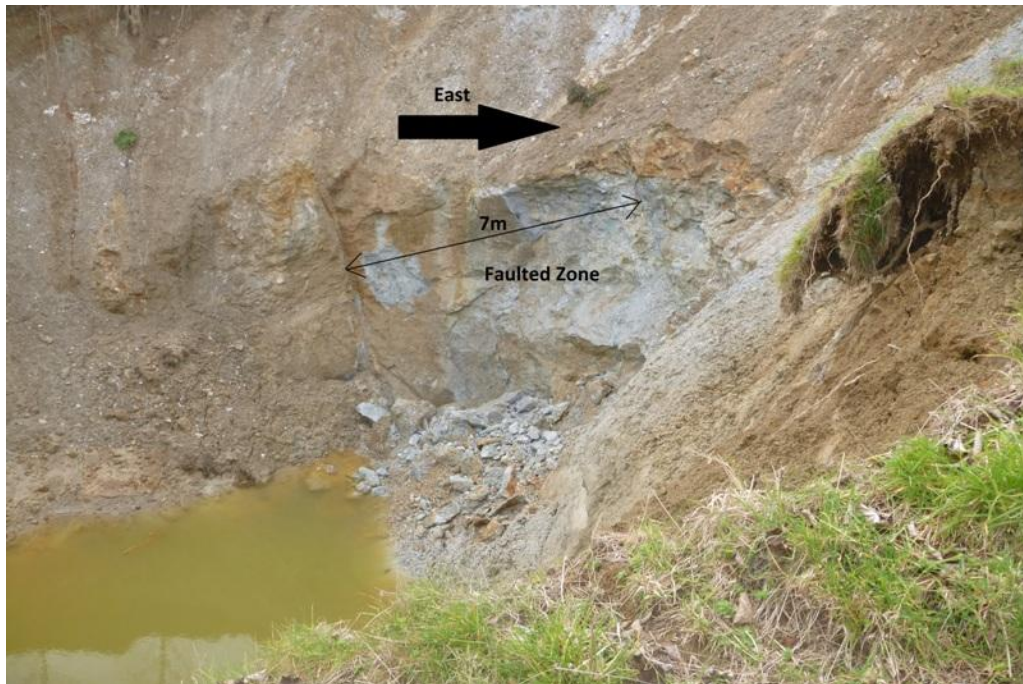
The sheared carbonaceous zone near the surface is likely to be at least 7m wide as shown in Photograph 4 below and may become wider with depth. Based on a geological cross section by Rabone (Ref. 9), the location of the highest level open stope workings on the Empire Vein and the position of the collapse, we consider that this fault is either the Beefeater Fault or a splay from the Beefeater Fault.

Photograph 4: View of the fault zone

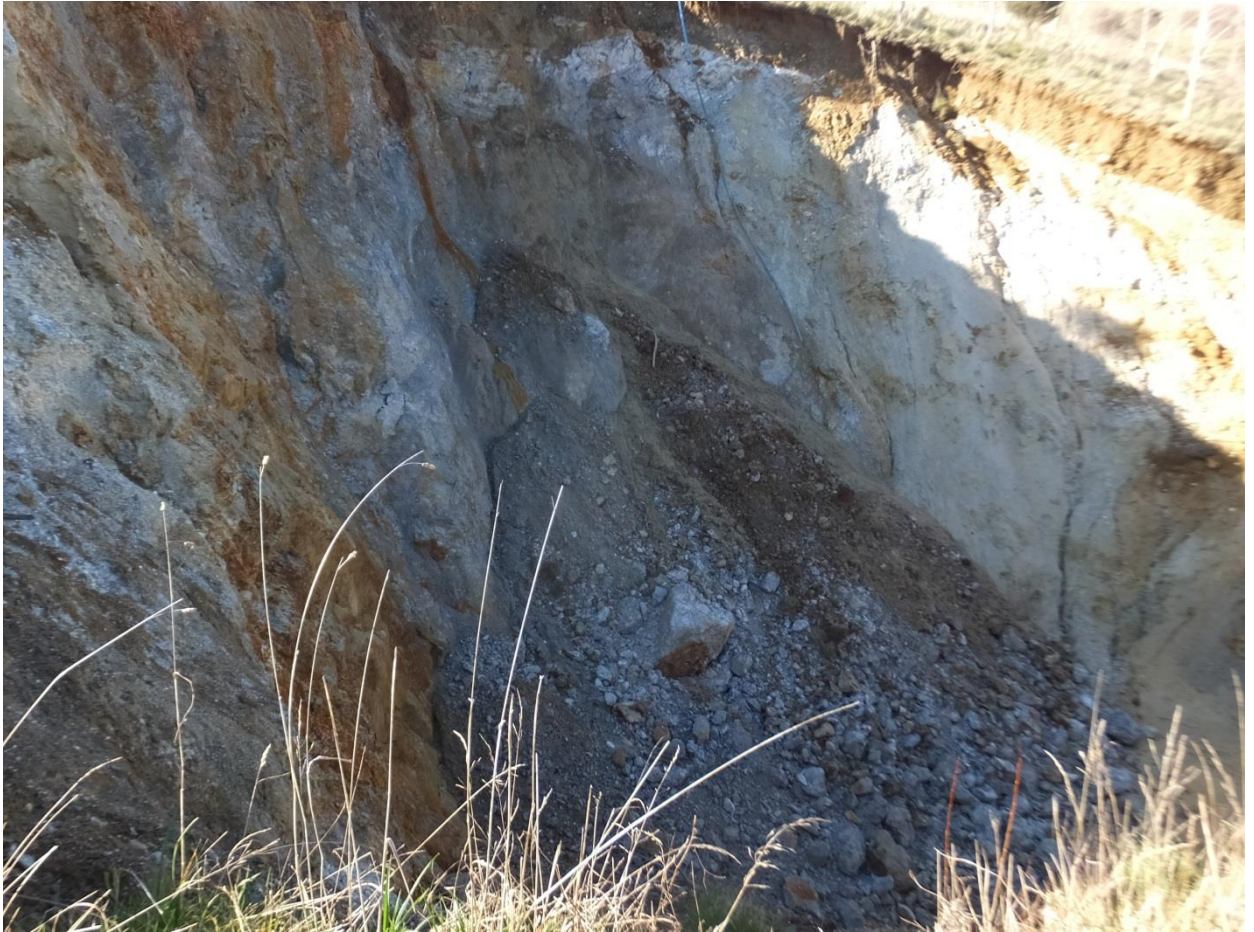
We walked around the perimeter of the crater inside the fenced-off enclosure. We noticed a north-trending subsidence crack on the northern side of the crater and a recent slope failure from the eastern side of the crater into its base (Photos 2 & 3). There was no water ponding in the floor of the crater, even though Jeff told us, there had been recent heavy rain (Photo 3).

Photo 2. *View of the sink-hole crater showing a fan of slope failure debris from the eastern side resting on the crater floor.*

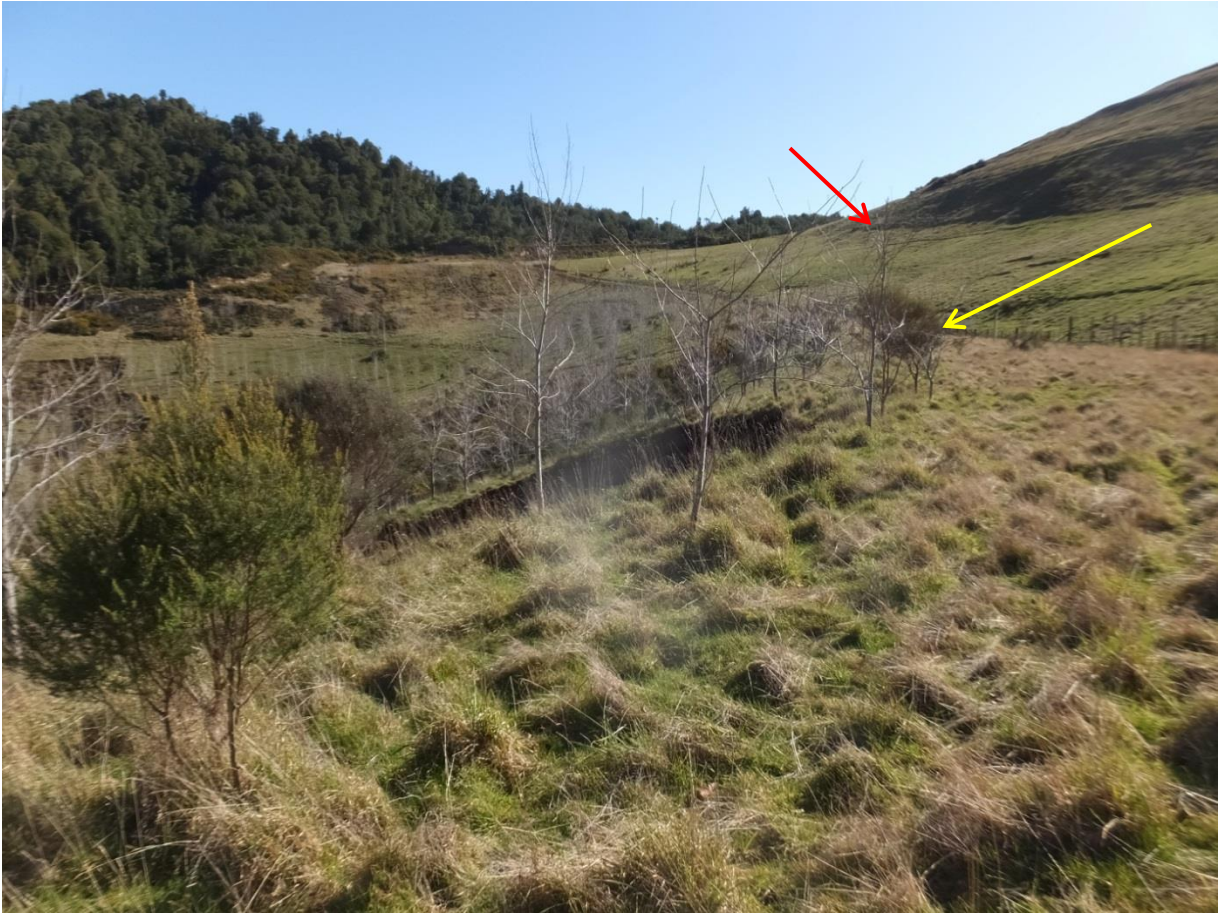
The sink-hole has exposed a small area of potentially acid generating rock within its crater. However, the area of potentially acid generating rock is limited and run-off from the sink-hole walls presently drains underground, where its impact through water treatment monitoring is shown to be negligible.

Photo 4. *View of the sink-hole looking NW. The public access walking track is arrowed red. The crater rim would have to enlarge eastwards some 20 m before it would capture the drain on the right (east) arrowed yellow. In summer the surrounding trees will obscure the view of the sink-hole, and hide it.*

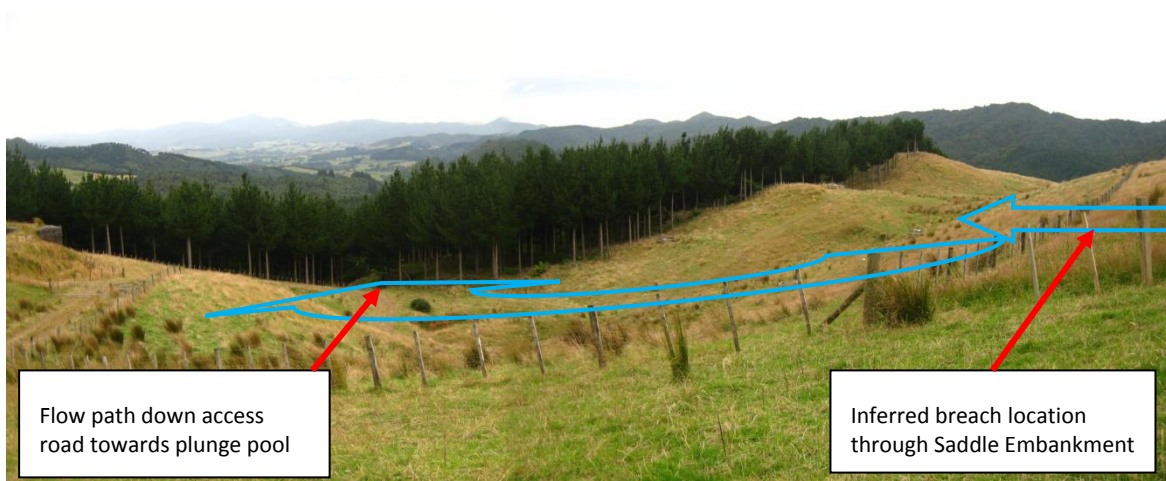
While some erosion damage is likely to the plunge pool and the concrete-lined channel, there is no other mining infrastructure located within the inferred flow path. An unquantified level of erosion would also occur on the ground between the breach location and the stilling basin but, as this is all natural ground, we would not expect this to be very significant and readily able to be repaired if that was considered necessary.

Photograph 1. Inferred flow path of possible dam breach release
