Post Closure Residual Risk Assessment

Golden Cross Mine

12 August 2016
42039944/R 003/D

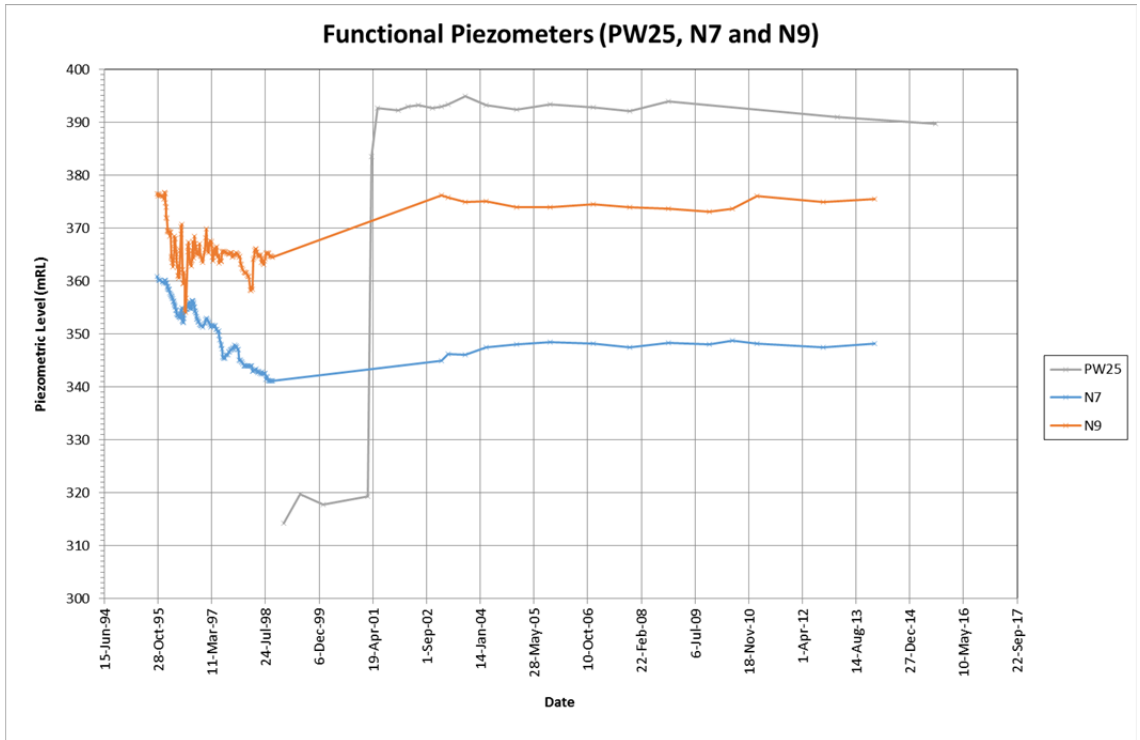
Figure 3-1 Piezometers PW25, N7 and N9

We have plotted the historical behaviour of the above piezometers with the exception of M8 which is outside the slide. The piezometer plots, shown in Figures 3-1 to 3-3, indicate that there have been some changes in water levels since 2003 when the stability model was updated to incorporate the measured piezometric levels.

The plots indicate that groundwater levels reached equilibrium by approximately mid-2013, although N132/2 and N132/3 rose an additional three metres reaching equilibrium in 2014. The plots show variability of the piezometer readings in the order of several metres. Since 2010 both N45 and N131/1 have risen by 4.54m and 5.98m respectively. N45 is showing a steady increase in water level whilst N131/1 rose during 2010-2013 and has shown steady results since 2013. These changes in water levels do not appear to be impacting landslide movement rates.

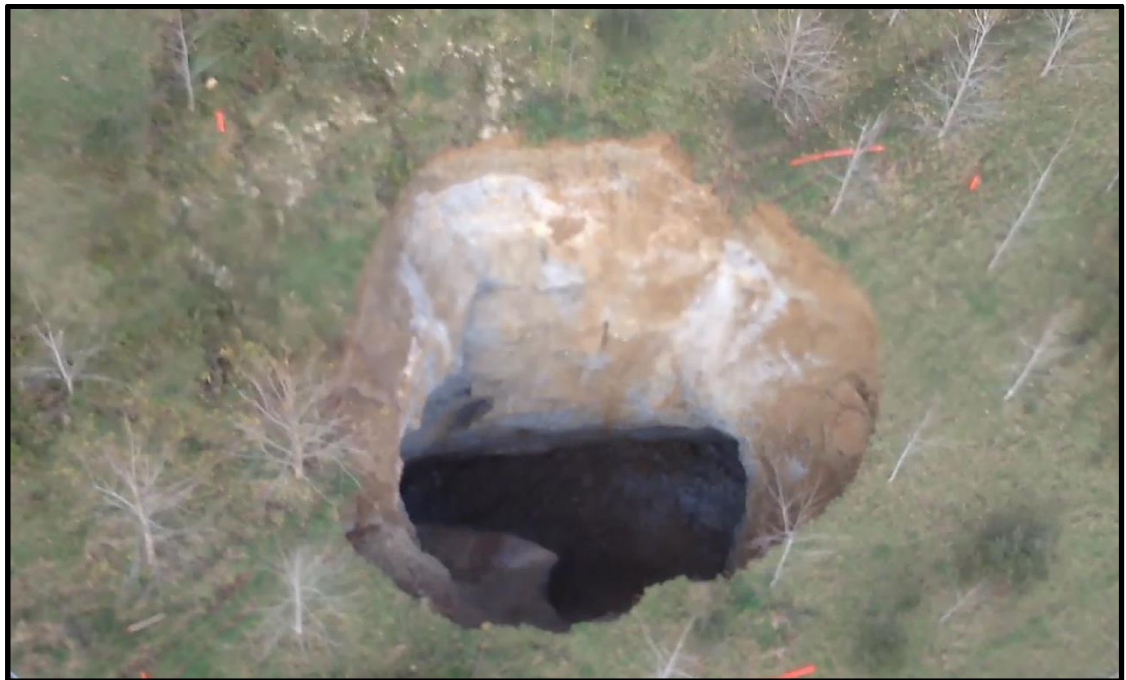
Figure 4-2 View from Helicopter into sinkhole 14 June 2013 (taken from Tonkin & Taylor video footage)

The sinkhole was initially described as approximately 20 m in diameter and 20 m deep. T&T staff visited the site on 14 and 20 June, and again on 26 July 2013 (see Figures 4-1 and 4-2). Over the course of these visits T&T observed that the sinkhole opening at the surface had enlarged in an upslope direction by 11.5m. Material from the upslope regression was backfilling the sinkhole and water was ponding on the top of the debris backfill (Figure 4-3). Reference pegs were installed around the sinkhole which were used for visual observation of changes and a safety fence was installed.

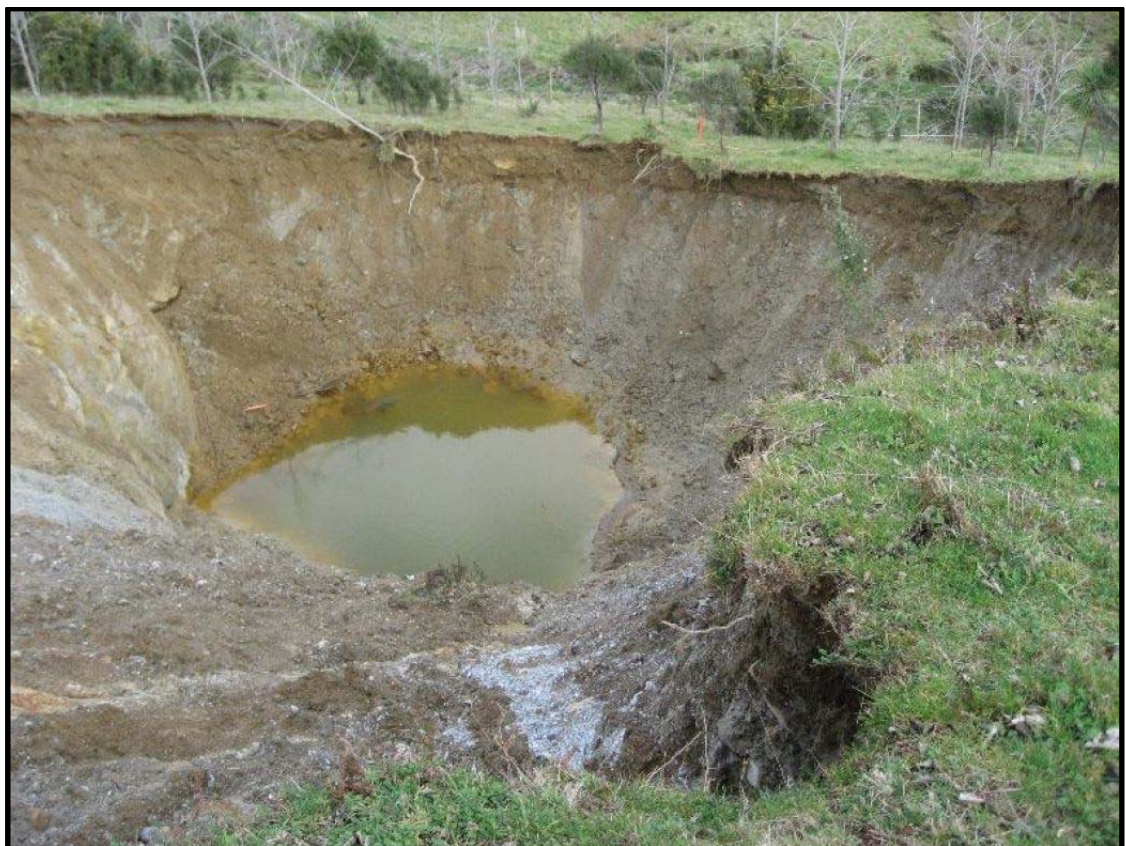
Figure 4-3 Debris filled sinkhole 26 July 2013

The fencing contractor reported a “soft zone” in the north- west corner of the fenced area. The 2013 T&T report considered this to be related to a shallow landslip feature and soft soil mantle.

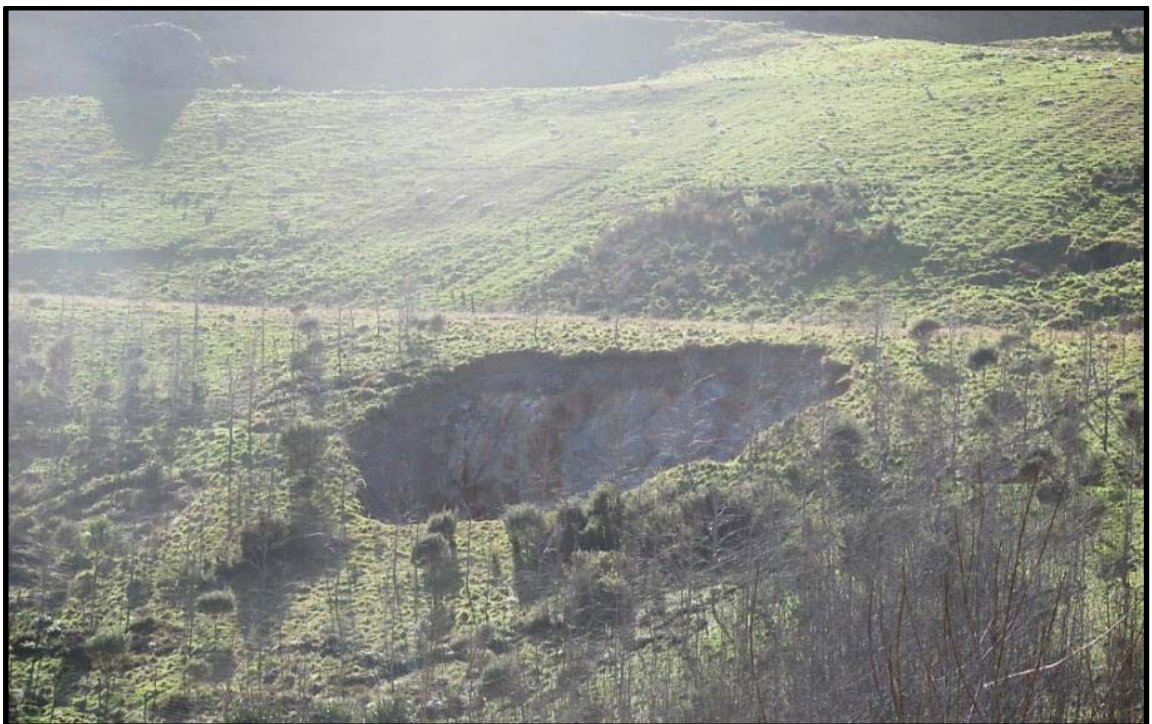
Figure 4-5 Enlarged view of sink hole July 2014

The scope of work for the revision of this risk assessment included a URS inspection of the site to view site conditions, including the sinkhole. This was undertaken on 24 July 2014. At this time the sinkhole was estimated to be about 40m in diameter and 20m deep and it was clear that the sinkhole had regressed further upslope. (See Figures 4-4 and 4-5). Comparison of 2013 and 2014 photography shows that the sinkhole has enlarged on the north, east and southern sides, however, the western margin appeared to be the same.

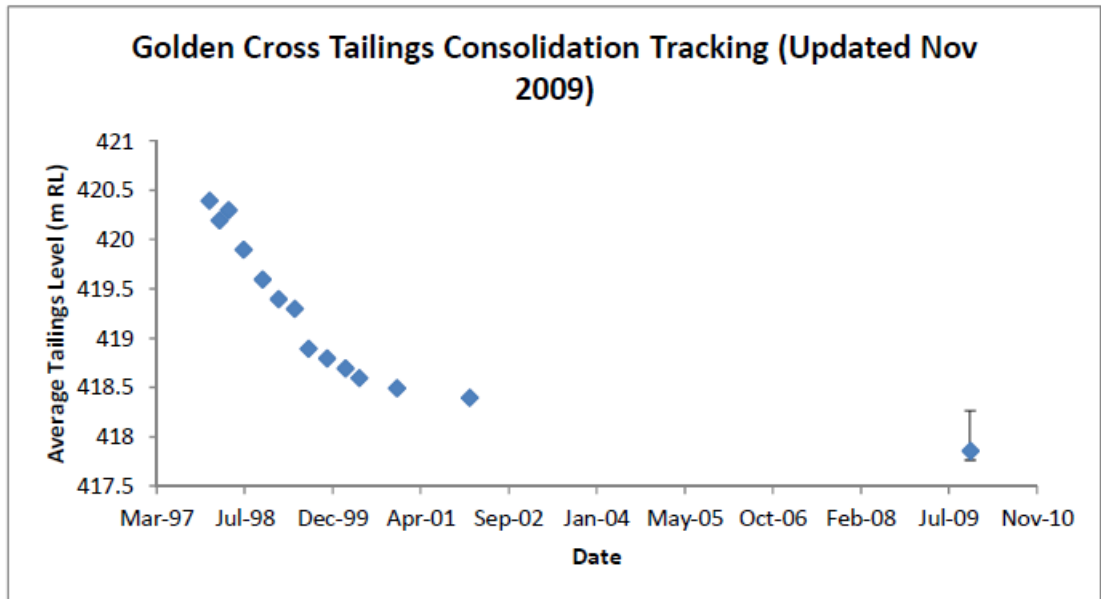
Figure 5-1 Tailings consolidation from 1998 to 2009 (from Tonkin and Taylor, 2013)

increasing the tailings strength (SKM, 2002). The most recent settlement survey was completed in 2009. Assessment of the settlement surveys has shown that the average settlement rate has reduced from 1.03 meters per year (m/yr) at the cessation of tailings deposition to approximately 0.08 m/yr in 2009 (T&T, 2013). The 2013 T&T report indicated that the tailings are still undergoing secondary consolidation beneath the cap.

Tailings consolidation data collected since the 2009 report shows that the rate of secondary consolidation continues to decrease, the tailings density is continuing to increase, which indicates a continuing increase in tailings strength over time.

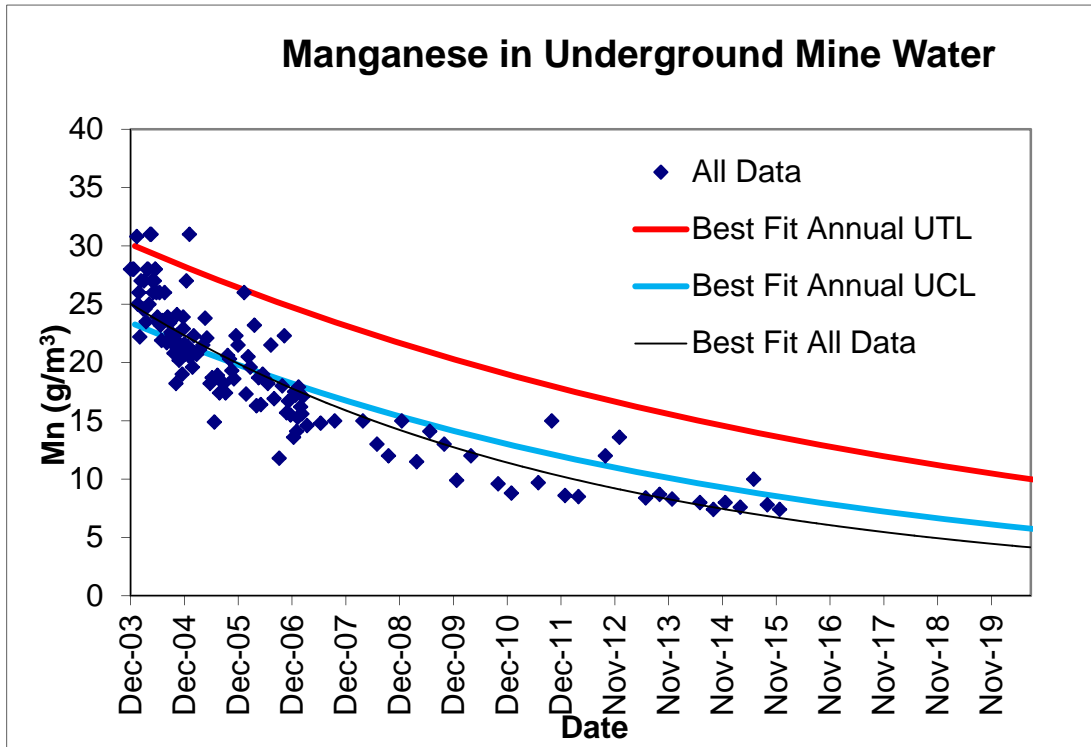
Figure 6-1 Manganese Trend (Best Fit)

Trends were evaluated using a least squares-fit analysis for manganese, exponential decay was found to provide a better fit than linear regression. The best fit (for all data) trend shows that the manganese concentrations without treatment will fall below $5 \text{ g}/\text{m}^3$ for the first time in 2018. Figure 6-1 below presents the best fit trend for manganese and the upper confidence limit of the mean (95%UCL) and upper bound (95%UTL) lines which are calculated for each year of data. The calculation of statistical limits (95%UCL and 95%UTL) requires data sets be grouped by year and minimises any bias due to differing sampling frequencies over time.

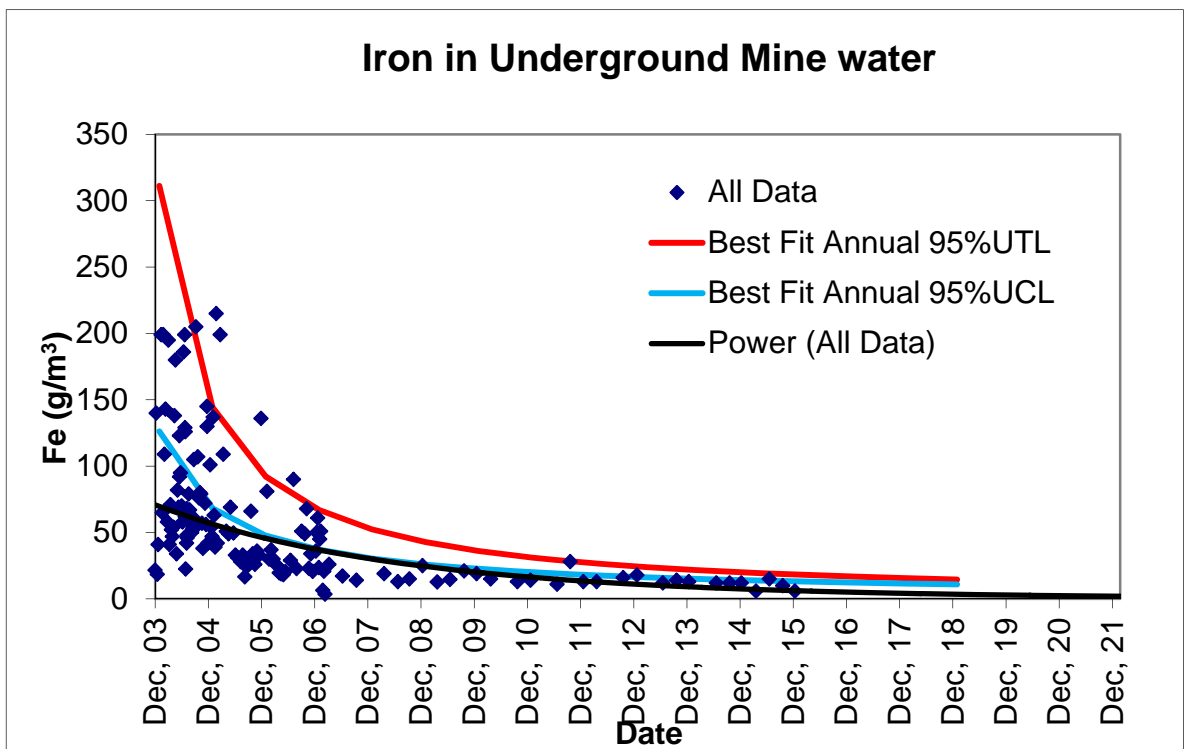
Figure 6-2 Iron Trend (Best Fit)

Trends were evaluated using a least squares-fit analysis for iron, exponential decay was found to provide a better fit than linear regression. The results show that the iron trend line will fall below $2 \text{ g}/\text{m}^3$ for the first time during or before 2021. Figure 6-2 below presents the best fitting trend for the iron, which is the decay trend.

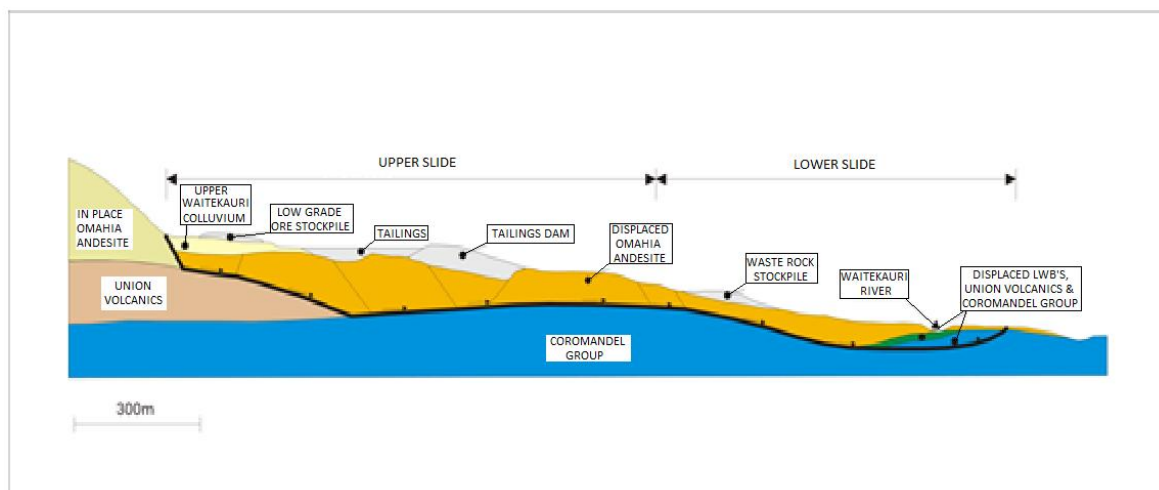
Figure 1: Golden Cross Landslide geological model

The landslide can be divided into upper and lower slides as demarcated on Figure 1 above. GPS monument C-K5 is located near the toe of the Upper Slide and C-Stok is located near the head of the Lower Slide.

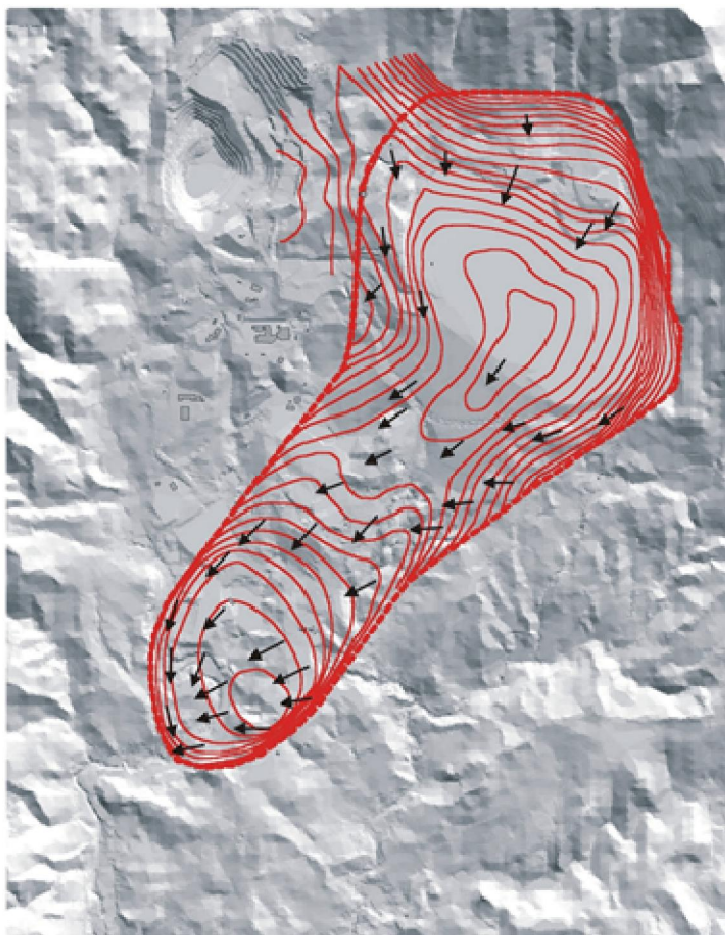
Figure 2: Golden Cross Landslide slide failure surface contours (10m intervals) and movement vectors)

Figure 2 below presents a contour model of the Golden Cross Landslide basal slide failure surface based on subsurface investigation and historic mass movement (inclinometer) monitoring data. The indicative slide movement vectors are based on surface monitoring data (GPS).

Additional and new GPS monuments monitored in the Upper Slide area include C-RA (Right Abutment) and C-136 (Rear of tailings). Right Abutment monument C-RA has displayed movement upslope toward the tailings impoundment in the monitoring period and over the last 12 years in a direction toward the middle of the Main Embankment. These movement directions are difficult to explain but are generally oriented in a down dip direction of the landslide lateral basal failure surface below (Figure 2).

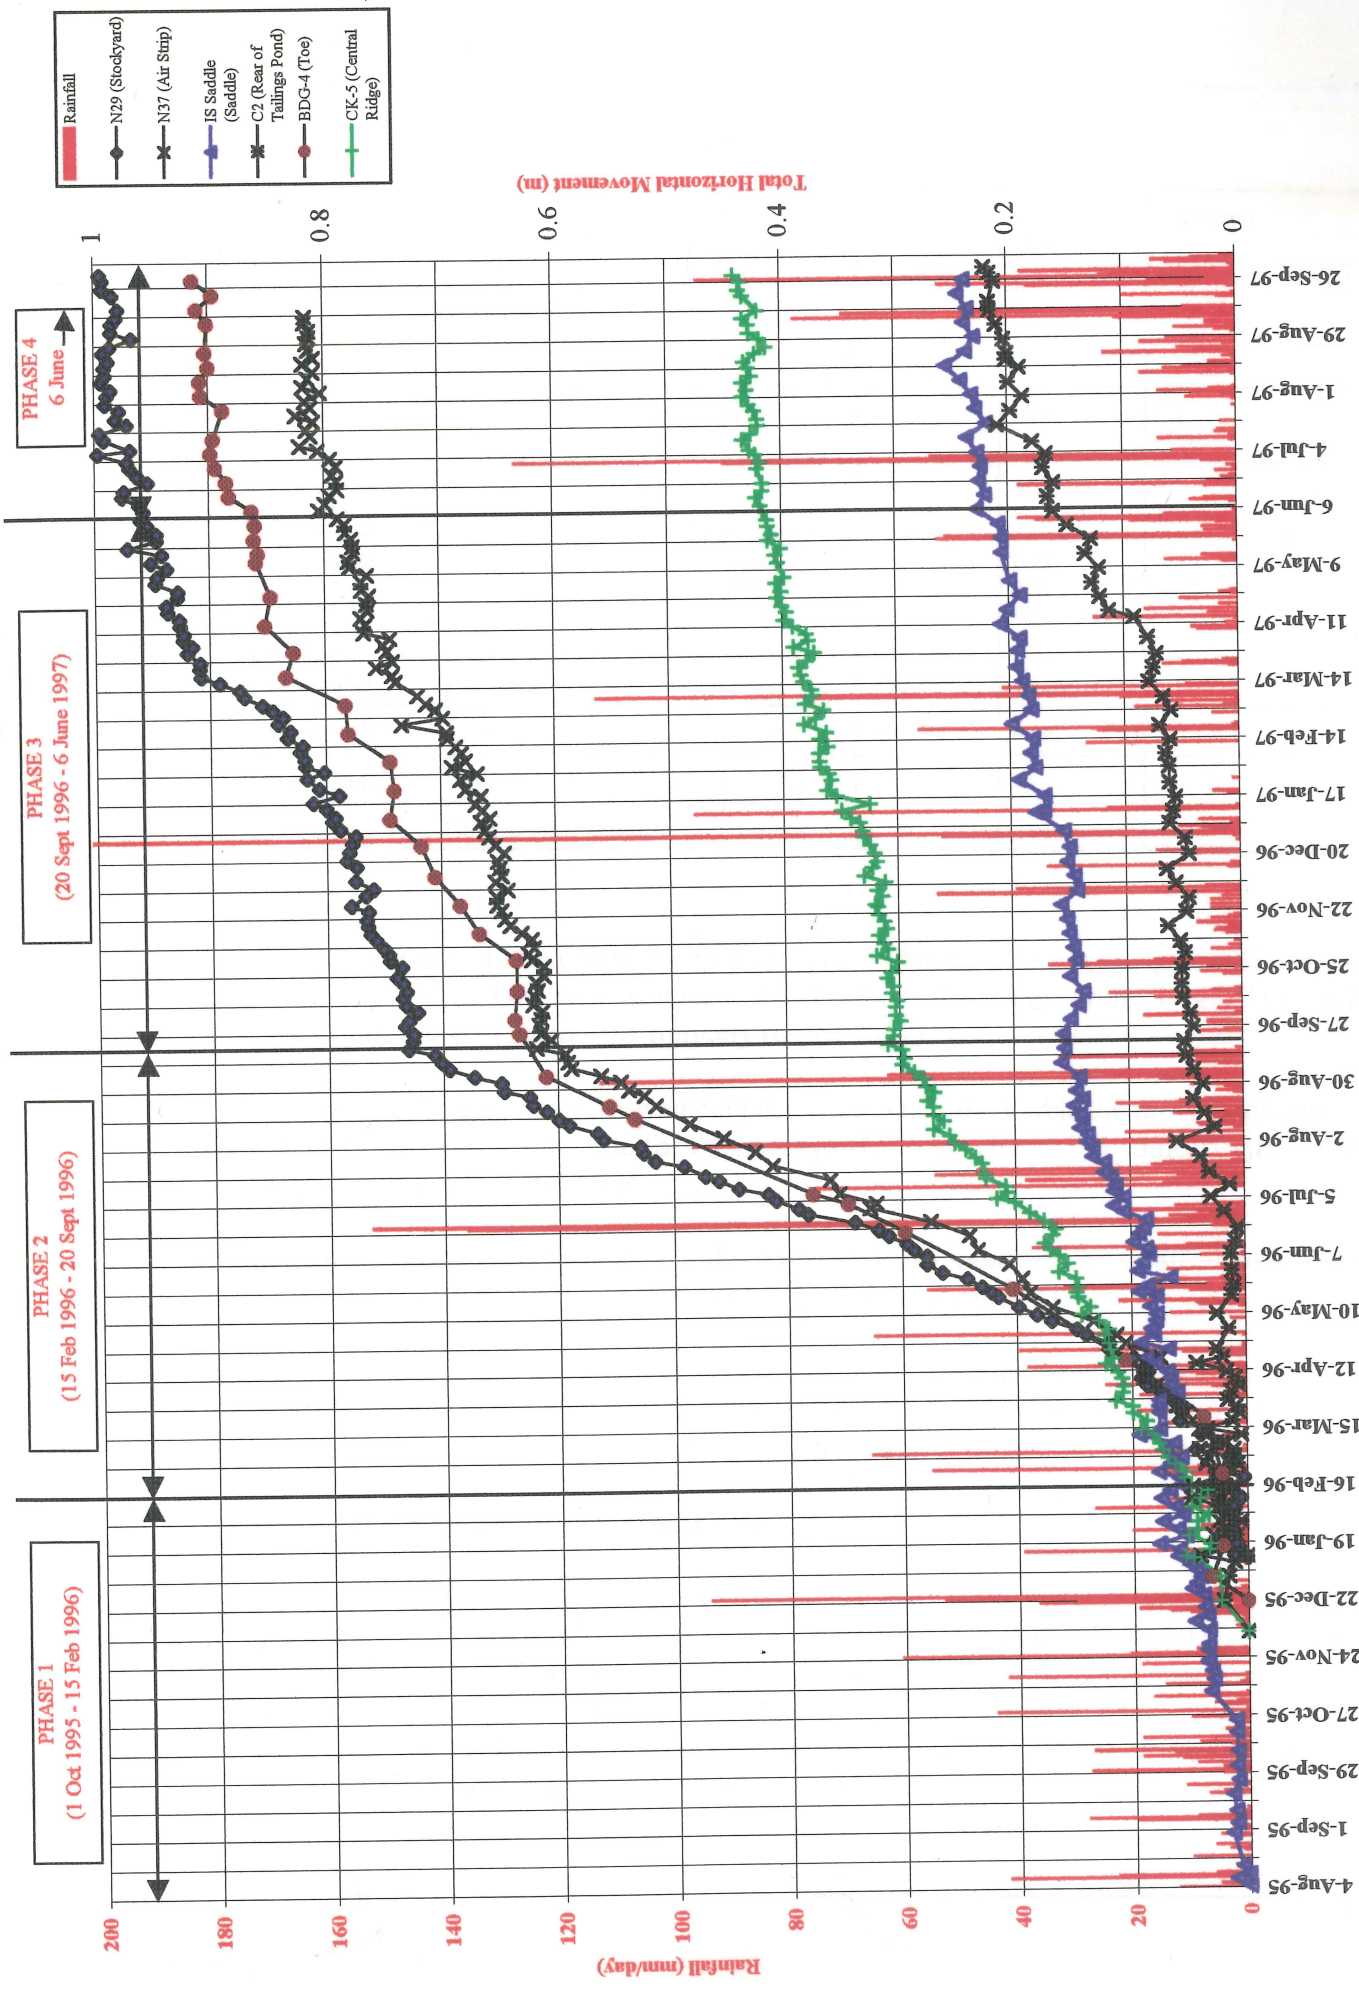
Figure 4.1 : GPS Total horizontal movement of the slide surface showing four main phases of movement activity.

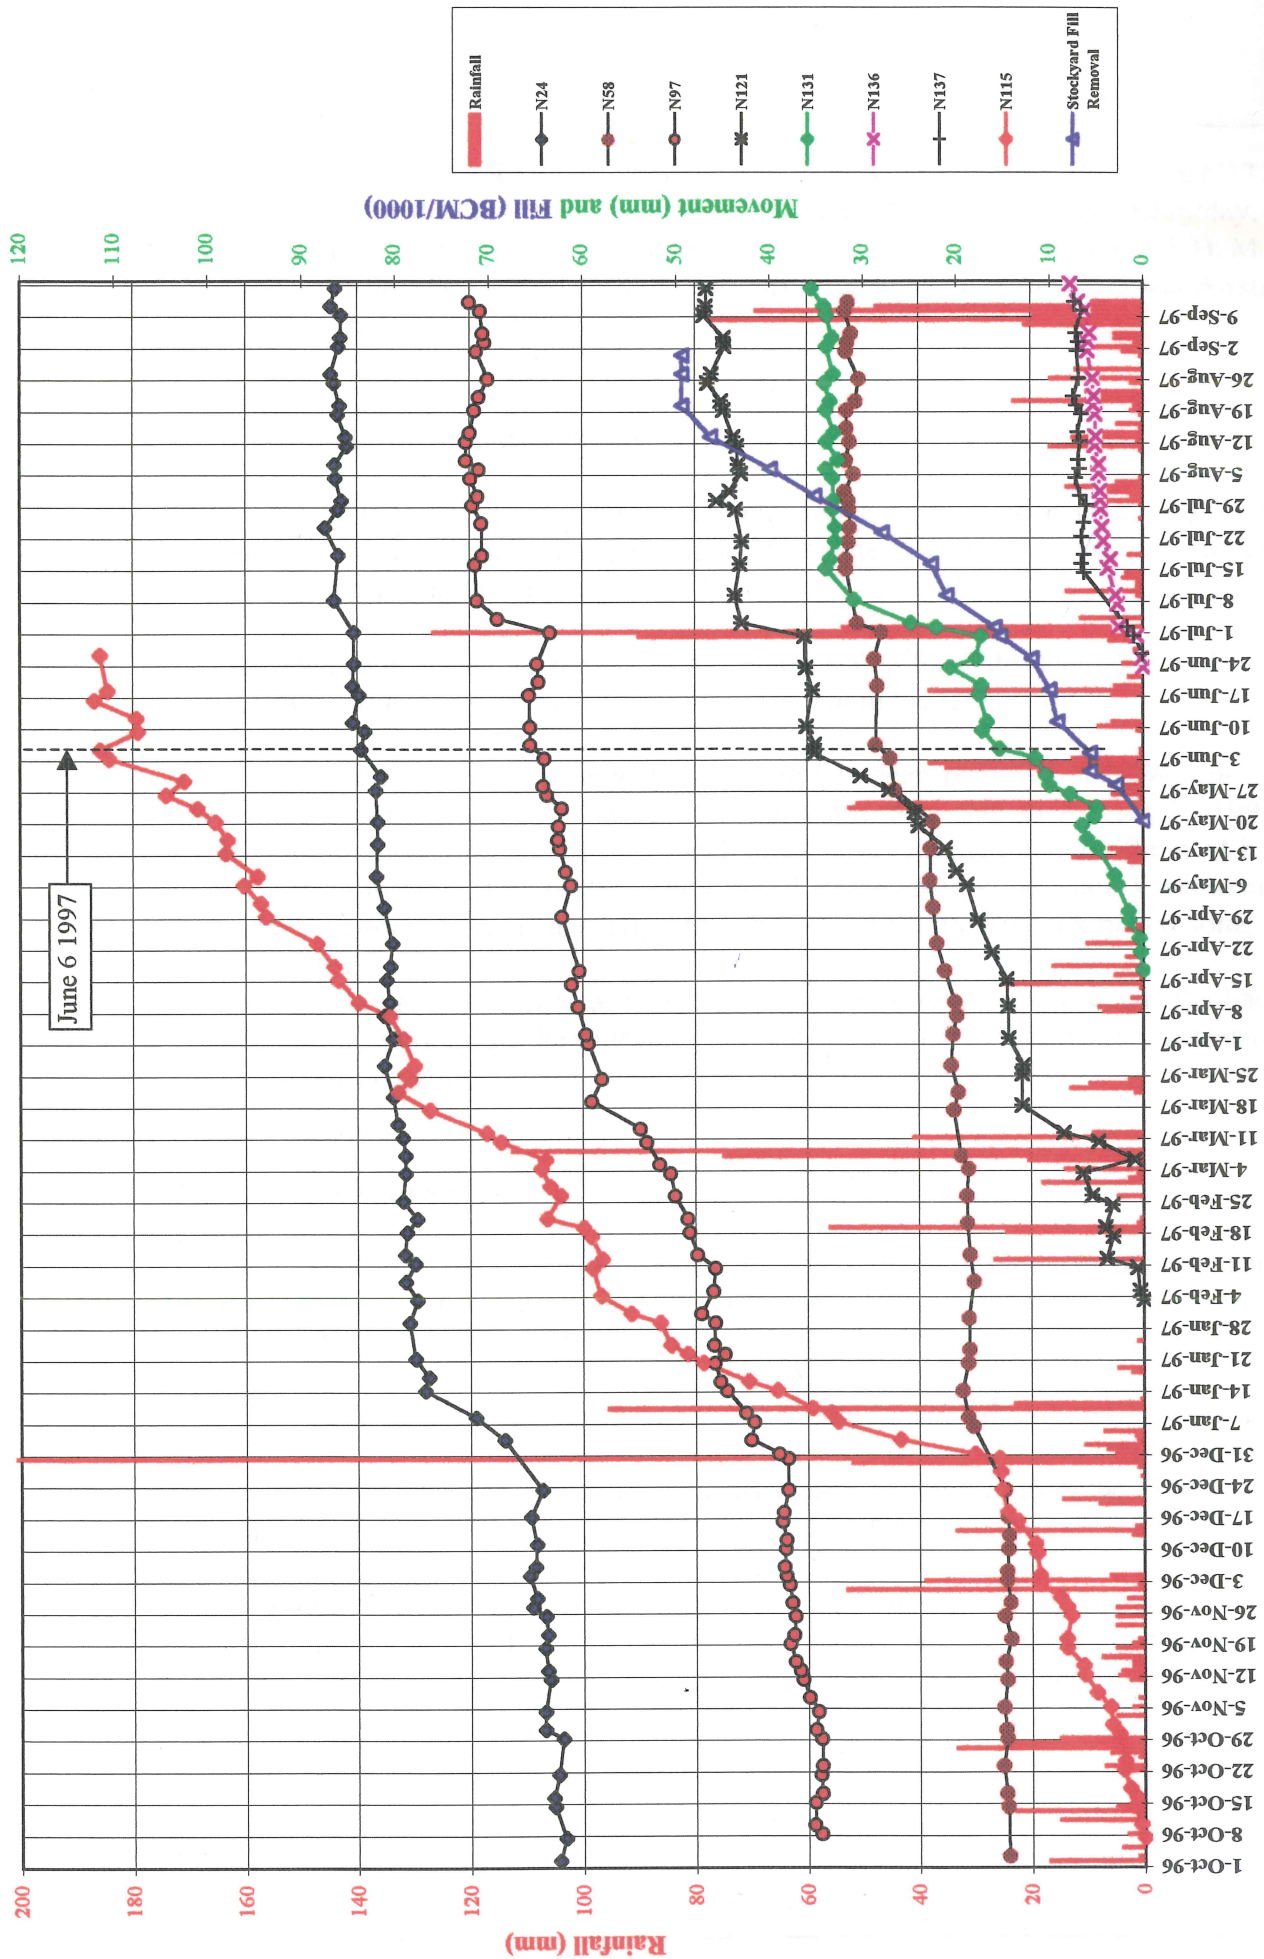
Figure 4.2: Inclinometer data showing change at June 6 1997 from continuous movement to "stick-slip" movement and to relative stability of the landslide. Note relative stabilisation is coincident with relocation of fill from the Stockyard Buttress to the Eastern Ore Stockpile.

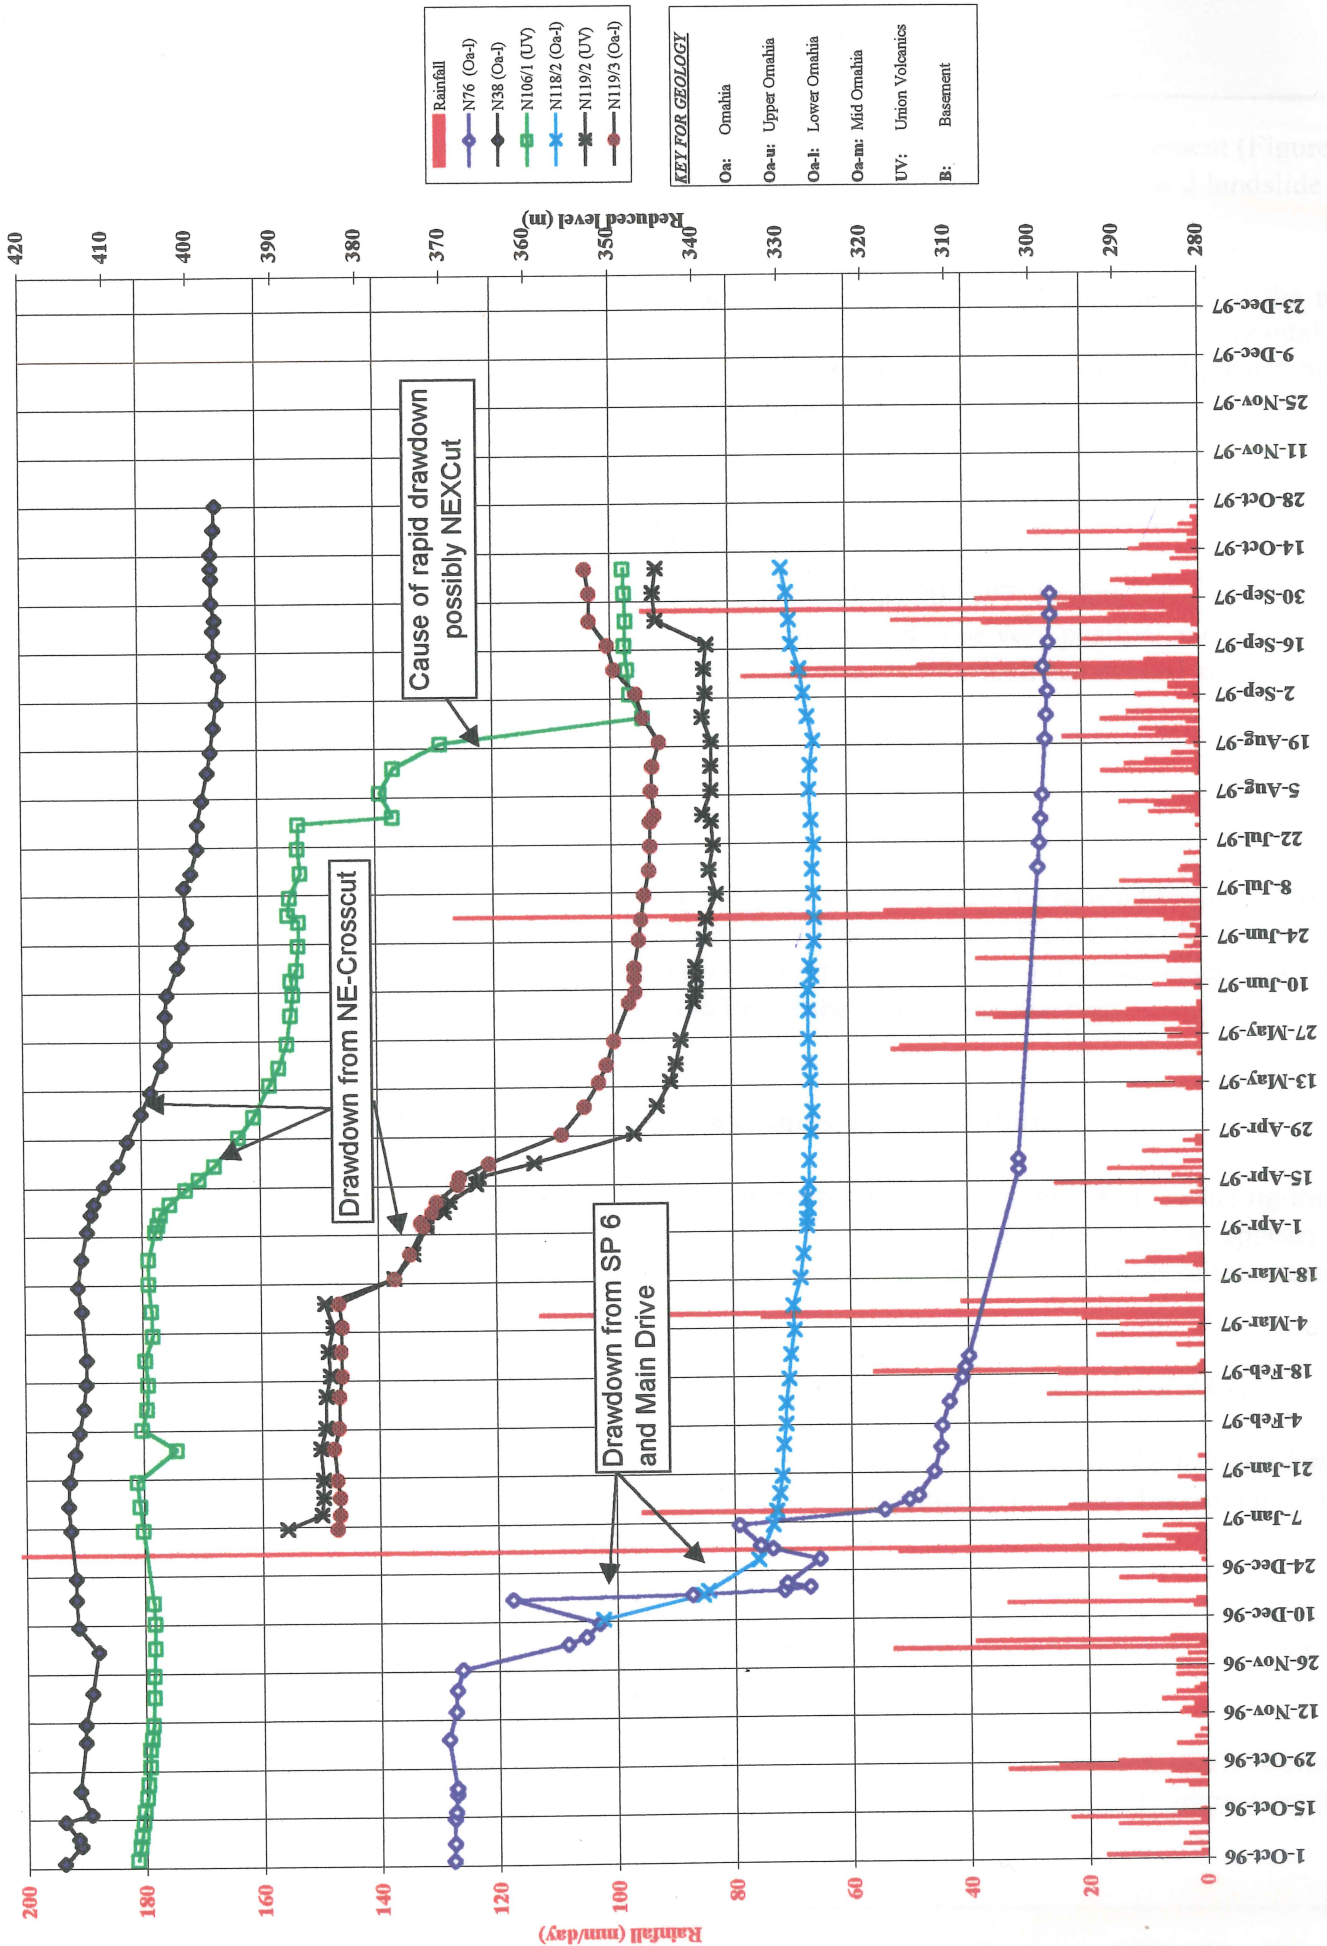
Figure 6.2: Piezometric drawdown recorded in response to drainage drilling from E46 Drainage Drive. Note rapid drawdown recorded by N76 and N118 (drilled into a large andesite block), and the NE-Crosscut induced drawdown recorded by N38 and N106 >350m to the NE.

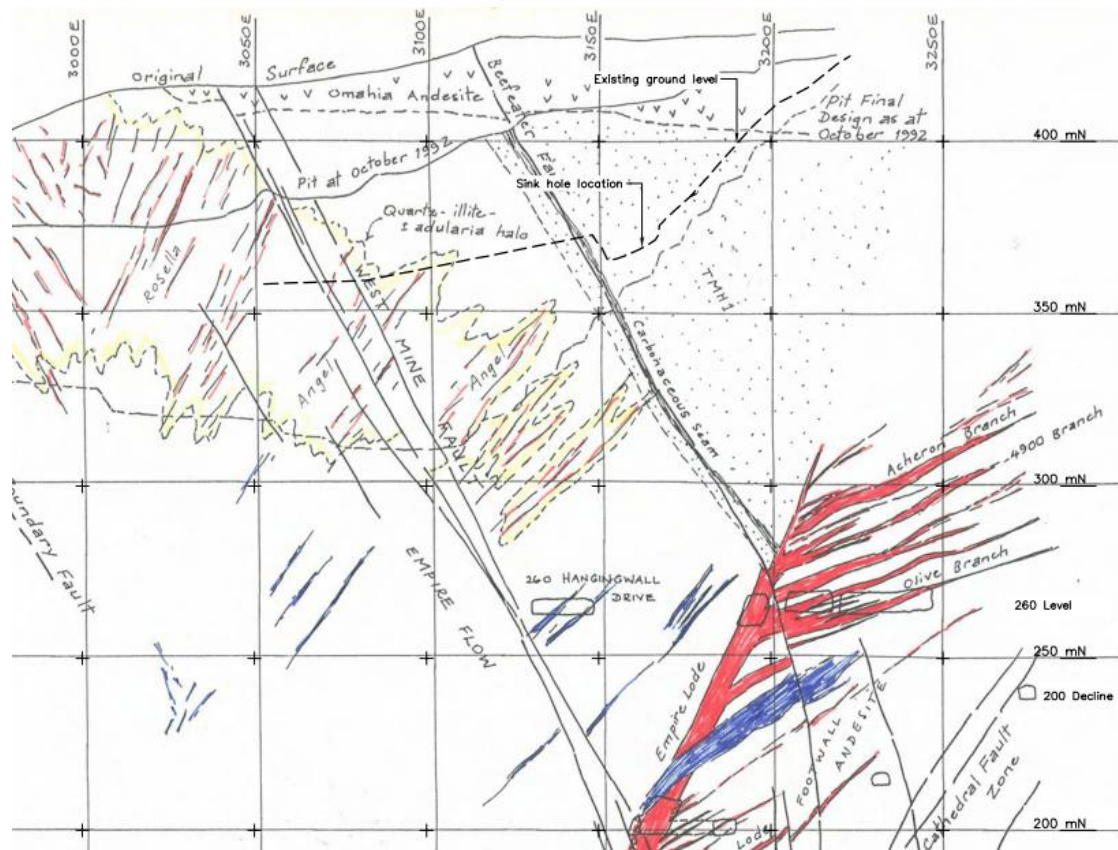
Geological Section 1: Figure 3-Generalised Geological Section 4850N in Rabone 1993

A projection of the steeply dipping faulted zone (Beefeater fault described by Rabone as a bedding plane shear along carbonaceous tuff horizons within the Tuff Marker Horizon) observed in the sink hole at the surface intersects with the blind long hole stope near the top of the upper panel above RL 300m (Stope 1) and the inclined non-backfilled room and pillar excavation from the Empire Vein at approximately RL 305m (Stope 2). All these stopes are above the current groundwater level. Therefore we consider it likely the bedding plane fault (Beefeater Fault) within the Tuff Marker Horizon has collapsed in a rectangular prism-like shape into the unfilled Stopes 1 to 2 and propagated all the way up to the surface (approximately 80m above the unfilled stopes) following the weak carbonaceous beds within the Tuff Marker Horizon. Accordingly, the angle of draw (10 to 30 degrees to the vertical) to the west of the upper unfilled workings is structurally controlled.

Geological Section 1 below is a cross section from Rabone (Ref. 9) which shows the Beefeater Fault within the Tuff Marker Horizon intersecting the Empire vein, which is close to the subsequently excavated unfilled Stopes 1 to 2. The 26 July 2013 sink hole profile is also shown and it is also close to the mapped Beefeater Fault.

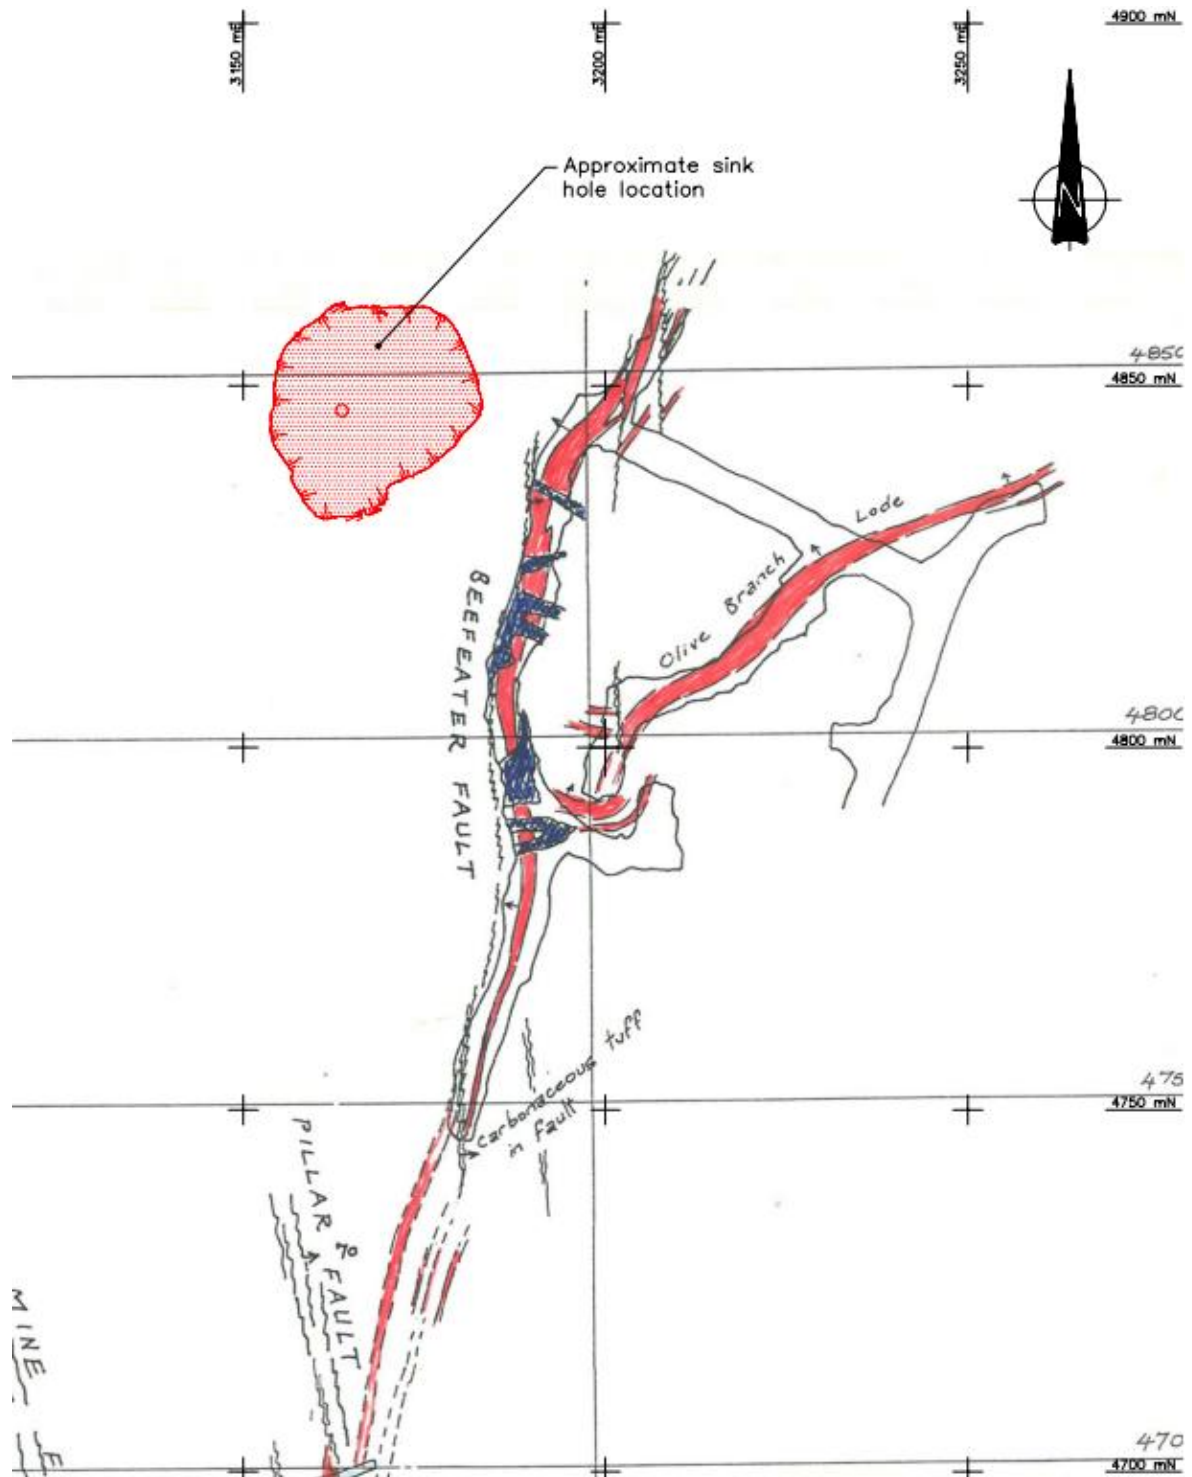
Geological Plan 1: Figure 1 - Simplified Geology at RL 280m in Rabone 1993. *Note the Empire vein, and branch veins are shown in red.*

Geological Plan 1 below is a plan of the approximate location and orientation of the known sheared carbonaceous beds and the Empire Vein (location of underground workings) at RL 280m. RL 280m is the closest horizontal section produced by Rabone to the known upper unfilled stopes. The plan has been used to determine the intersection length of the faults and unfilled underground workings.

The underground workings above RL 297m extend over a length of approximately 200m (1996 Minesight Model). Based on an essentially parallel strike of the Empire Vein (i.e. underground workings) and sheared carbonaceous beds, we have conservatively assumed the known sheared carbonaceous beds intersect the upper unfilled workings over this entire 200m length. Based on an angle of draw of 10 to 30 degrees to the west of the upper unfilled workings, a 50m width perpendicular to the underground workings is considered at risk. This equates to a 10,000m² (1.0 ha) surface footprint risk area.

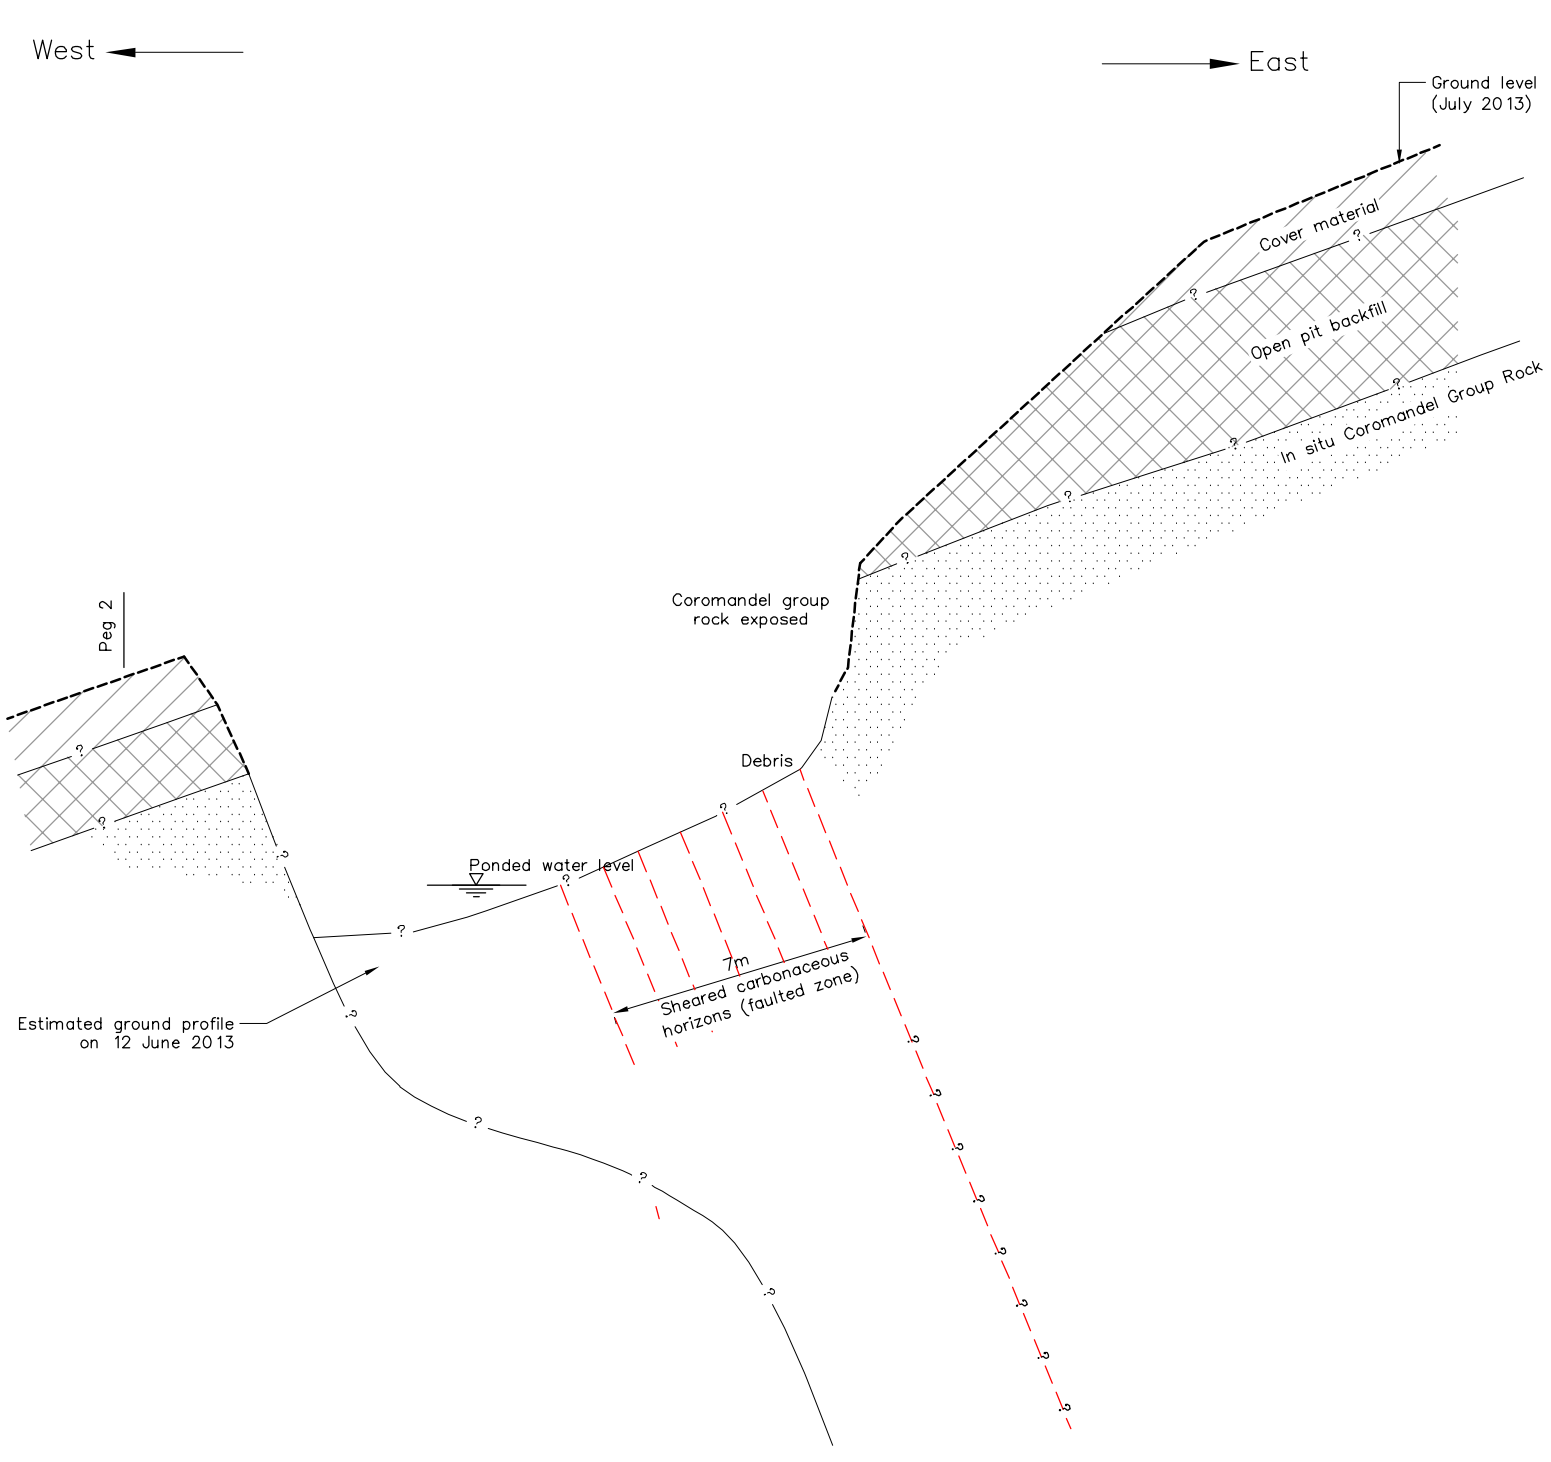
SECTION 2 SINK HOLE CROSS SECTION
SCALE 1:200

Study of a video made during the helicopter flight and photographs taken from the ground clearly showed that the sub-vertical walled collapse shaft (at the base of the sink hole) was a structurally controlled geological feature. The shaft had a rectangular shape which was somewhat elongated in a NNE to SSW direction and appeared to have been formed by rock mass defects dipping steeply to the east. The initial impression was that the collapse shaft lay between the footwall and hanging wall of a faulted zone in the rock mass which intersected the ground surface on the sloping eastern side of the open pit. A number of unfavourably orientated defects were noted on the eastern (upslope) side of the sink hole and further regression of the shaft upslope (to the east) was anticipated. The depth of the (visible) sink hole was measured by handheld laser from the helicopter as 20m below ground surface on the downslope side.

The volume of the sink hole measured as an inverted truncated cone is between 2000 and 3000m³ based on the most recent measurements taken onsite. Therefore, based on a relatively low to nil bulking factor, approximately 2000m³ to 3000m³ of material could be present in the unfilled stope(s) below. Stopes 1 and 2 comprise the following volumes based on the approximate average plan area (from the Minesight Model) and typical stope height (Ref.7):
