Post Closure Residual Risk Assessment

Golden Cross Mine

12 August 2016
42039944/R 003/D

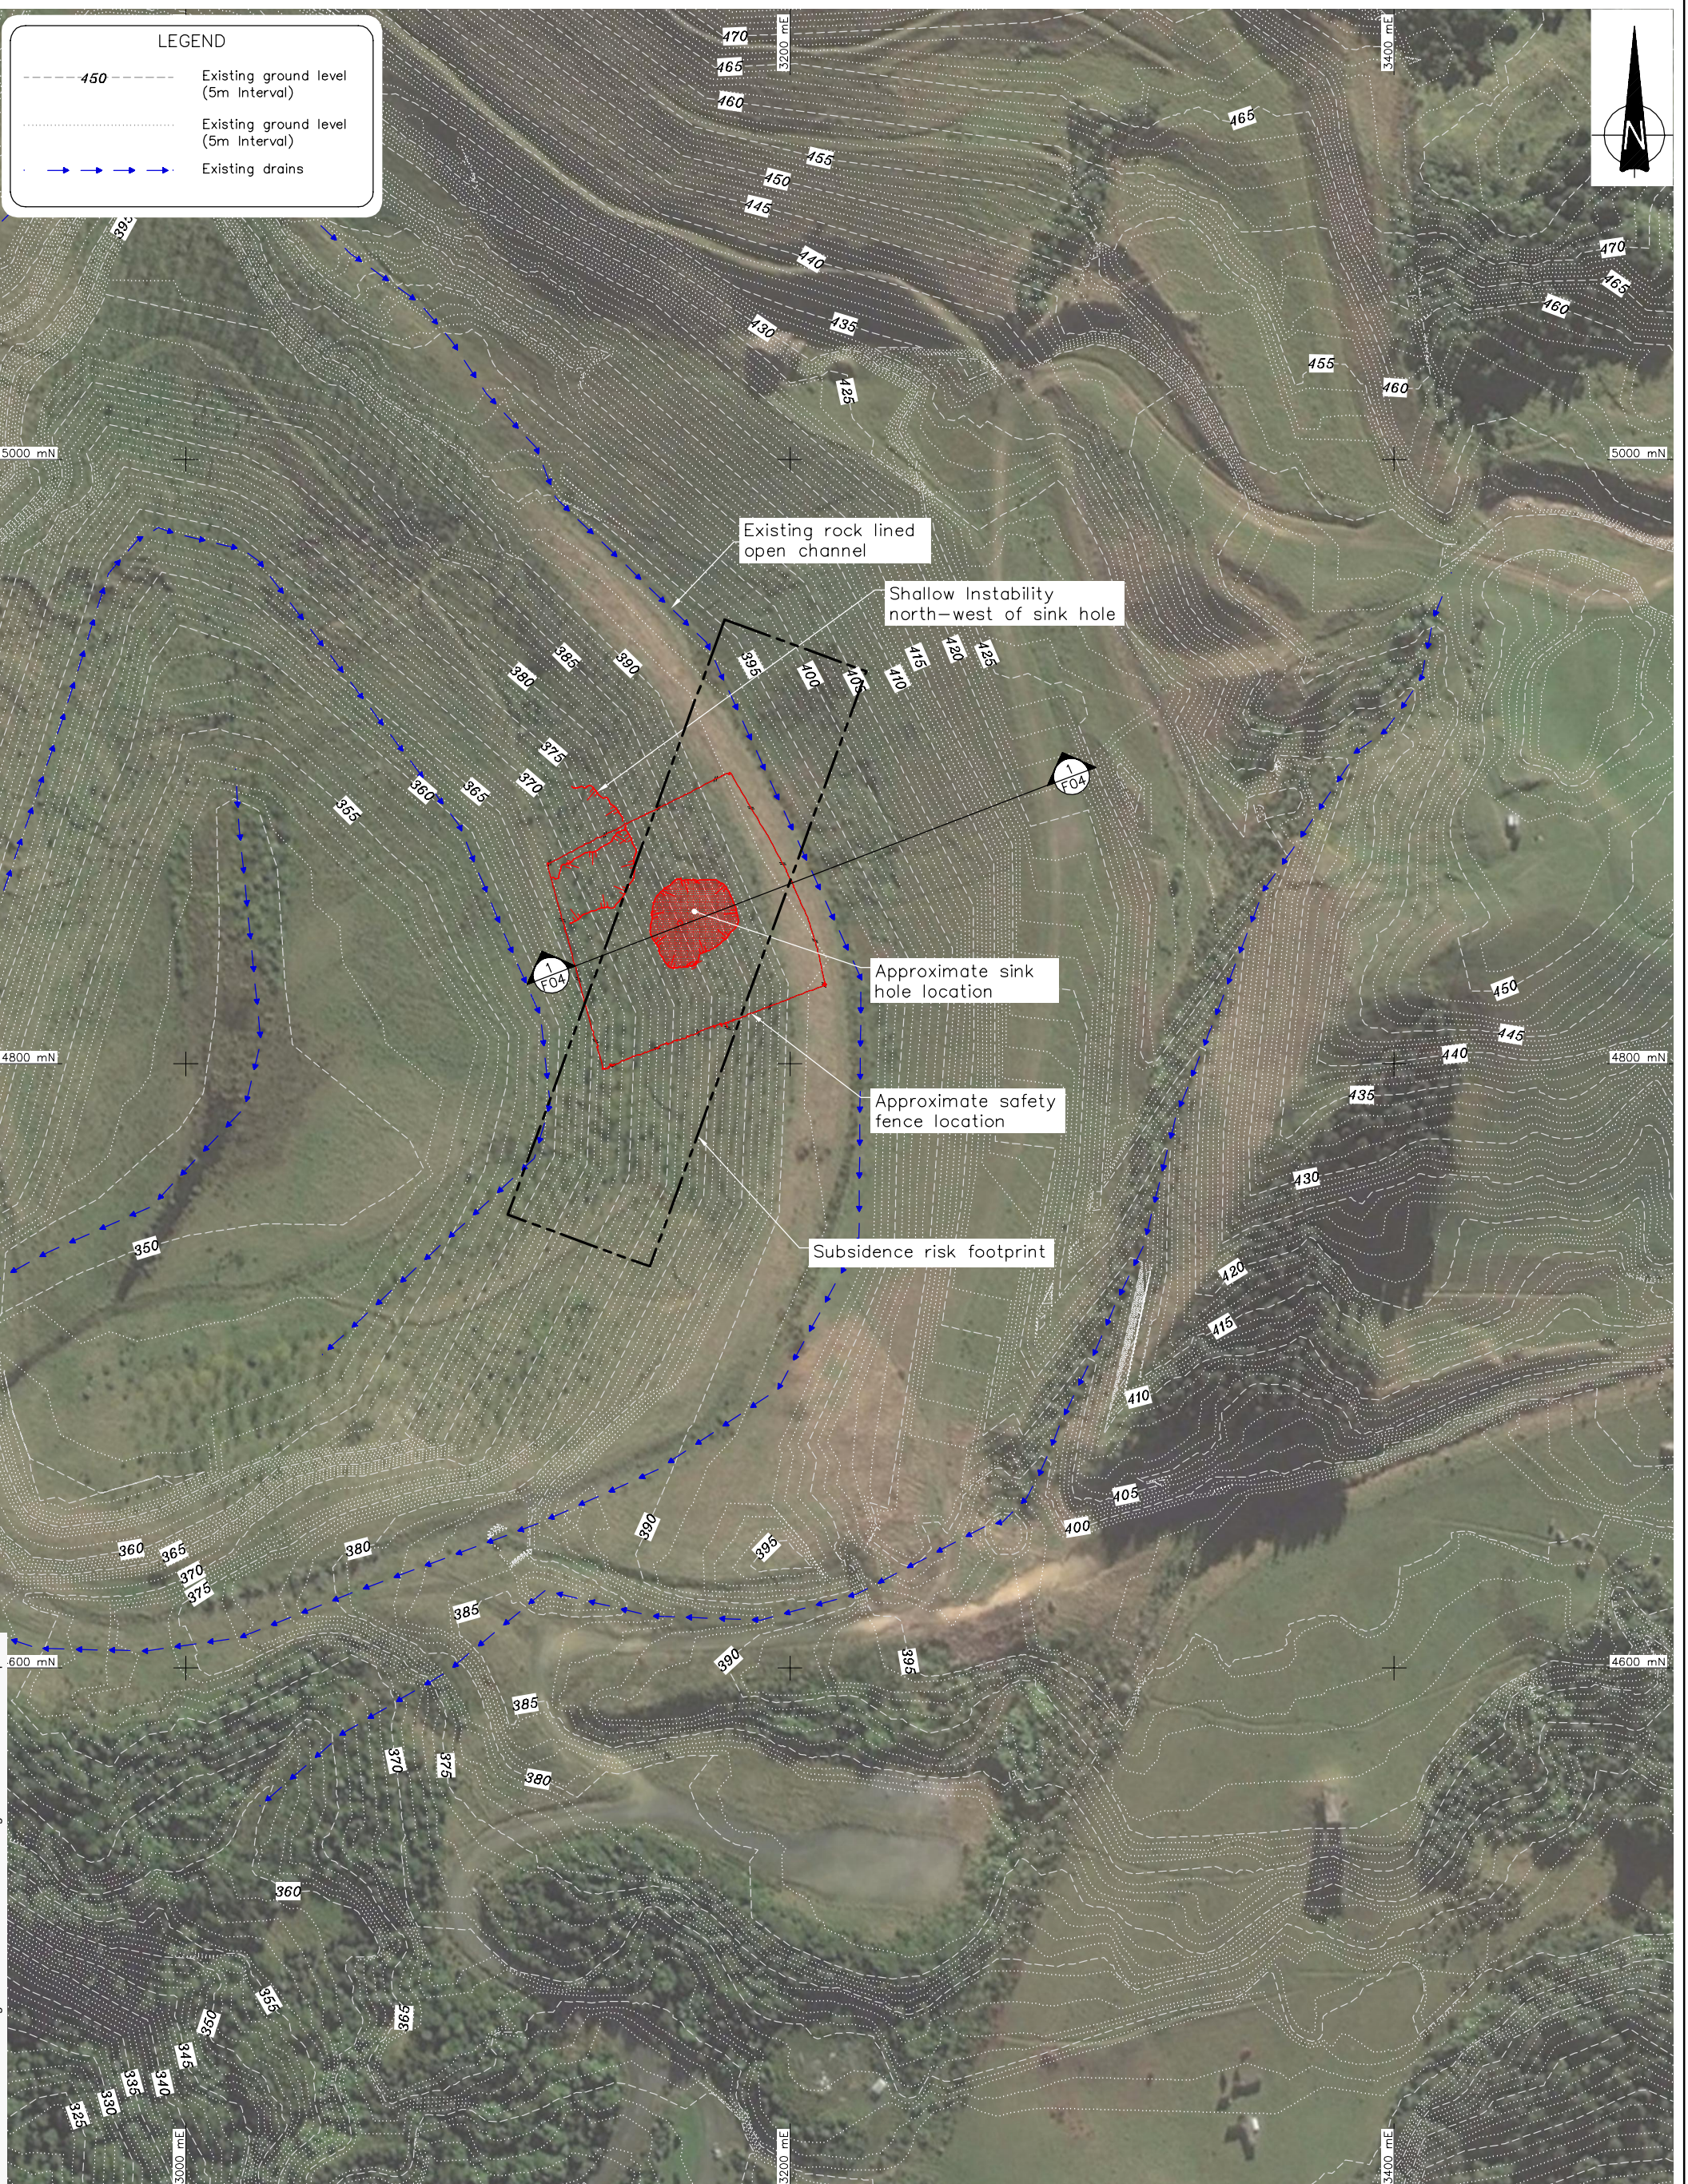
FIG. No. **Figure 6**

The surface footprint risk area is defined as the surface area at risk to subsidence and is indicated on Figure 6 in Appendix B.

Surface water from above the feature and from a small mid-slope open pit channel is able to drain into the sink hole at the present time. Remedial works to divert surface water from entering the collapse shaft and the subsidence risk footprint shown on Figure 6 (Appendix B) should be undertaken as soon as possible.

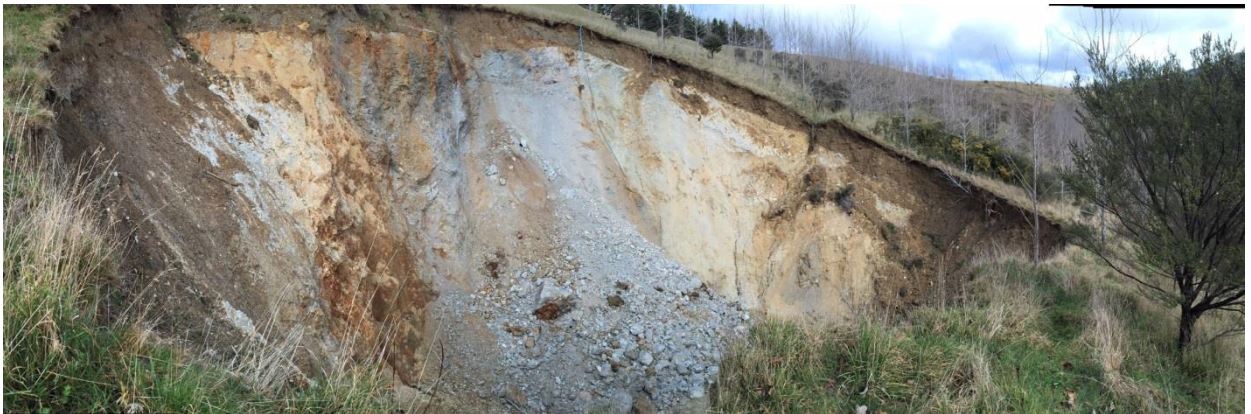
A sub-vertical sided sink-hole was noticed on 12 June 2013, on the eastern side of the closed and rehabilitated open-cast mine pit at Golden Cross Mine. The sink-hole was initially some 20 m in diameter, and has now enlarged to be some 40 m in diameter.

Photo 1. *View of the sink-hole “crater” in early September 2015 (courtesy of Paul Burton, T&T)*

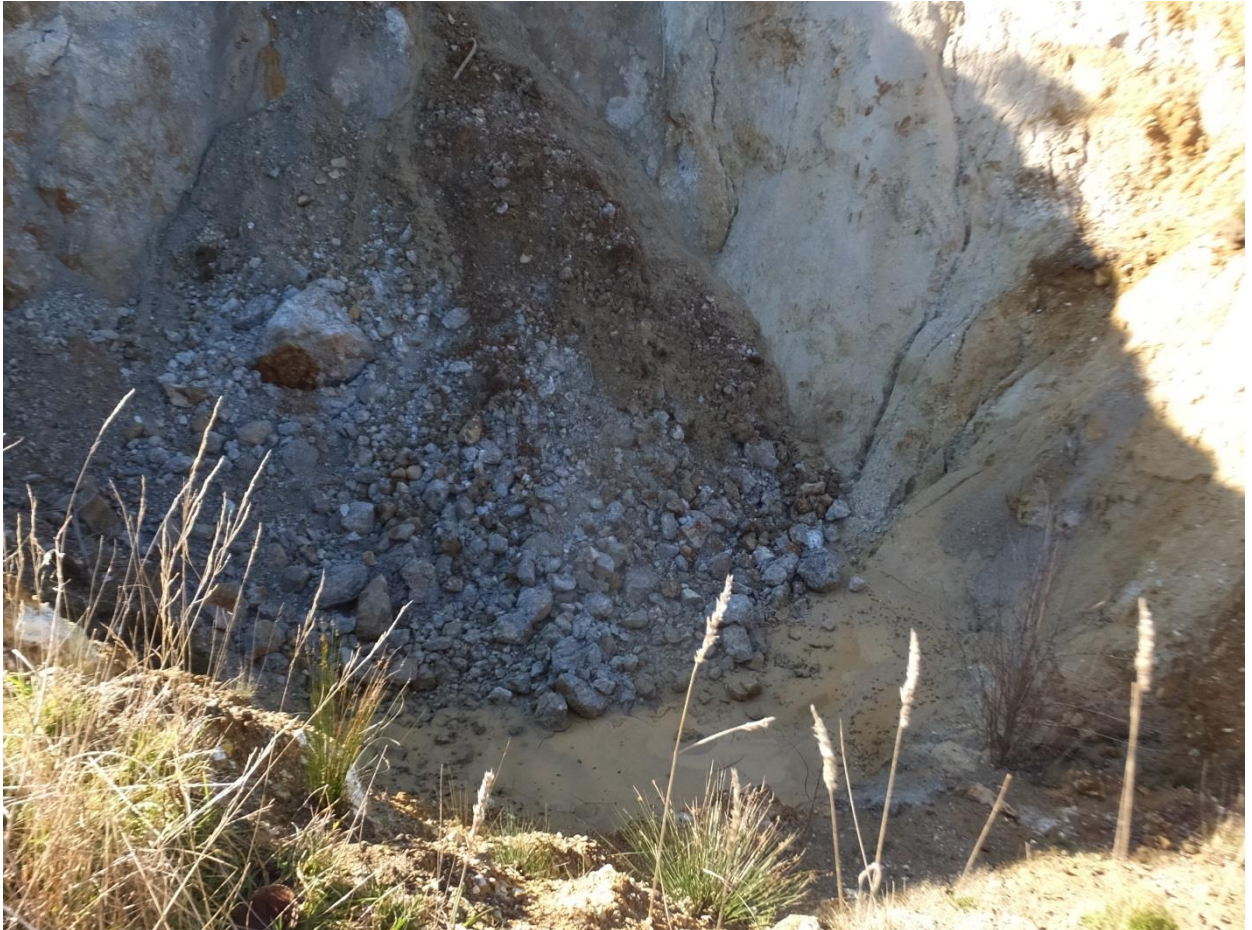
We walked around the perimeter of the crater inside the fenced-off enclosure. We noticed a north-trending subsidence crack on the northern side of the crater and a recent slope failure from the eastern side of the crater into its base (Photos 2 & 3). There was no water ponding in the floor of the crater, even though Jeff told us, there had been recent heavy rain (Photo 3).

Photo 3. *The crater floor at the toe of the debris fan has deposits of fine grained material that indicate (temporary) ponding of rain water.*

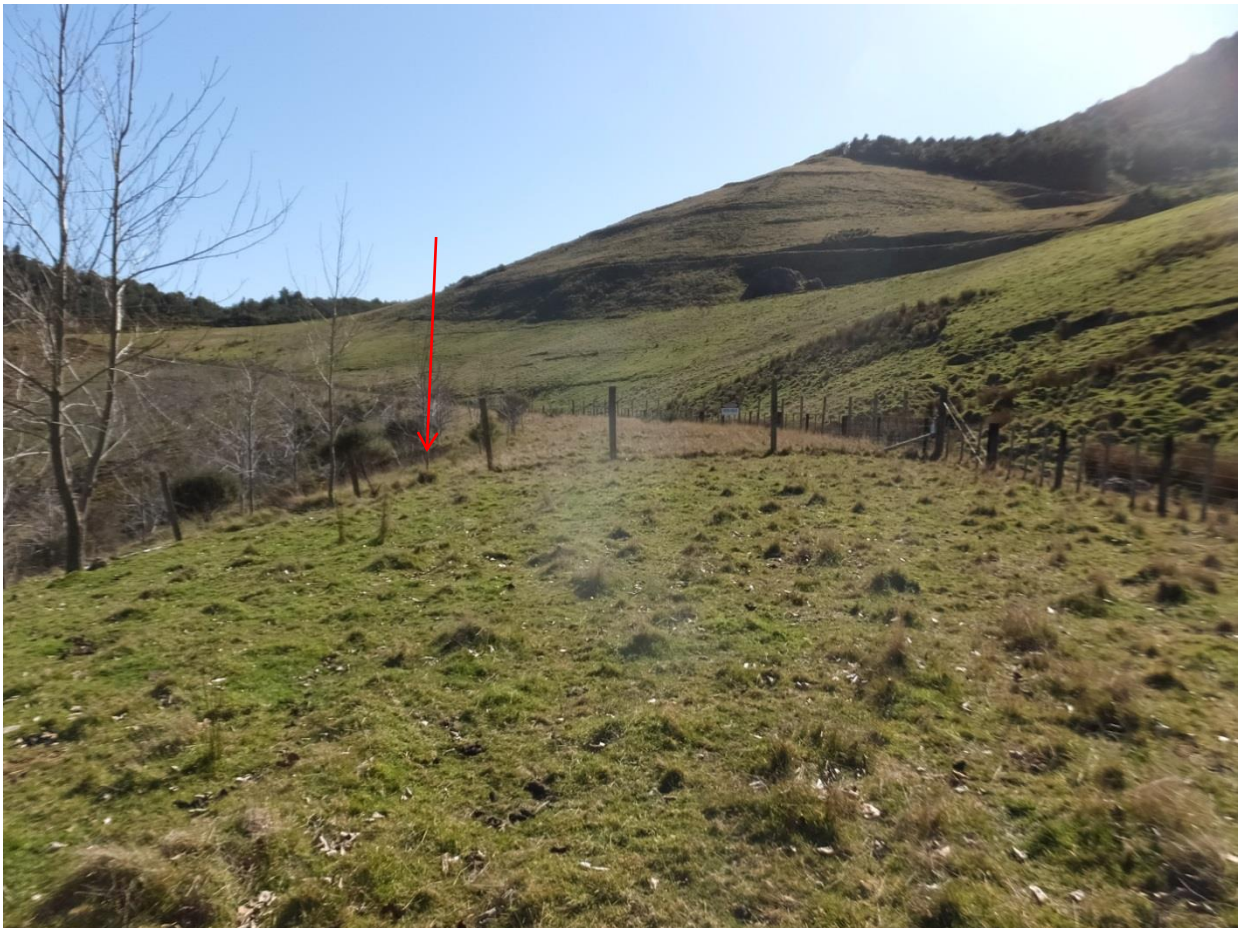
Photo 6. *View of the sink-hole enclosure fence and the sink-hole – just visible (arrowed), looking north.*

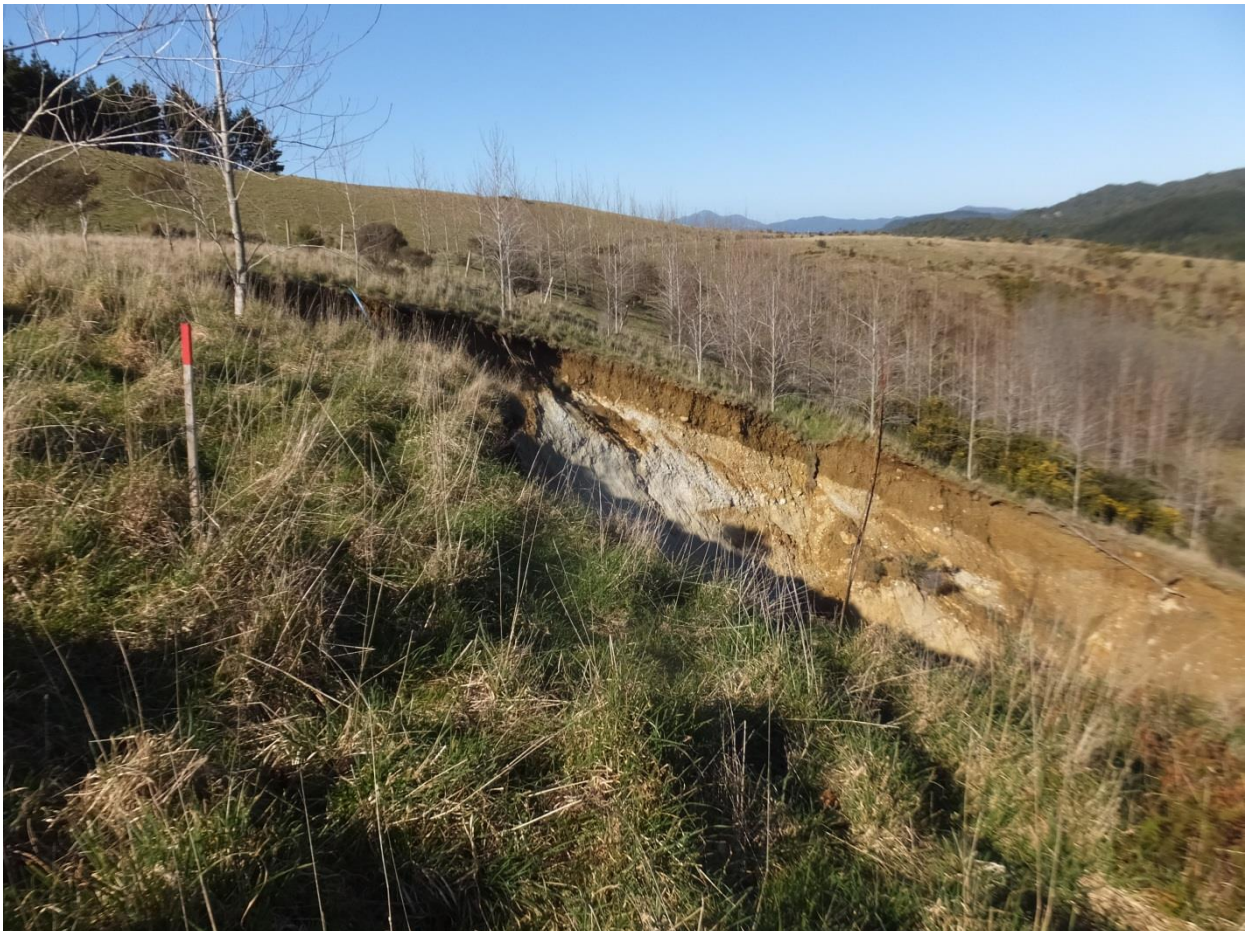
Photo 7. *View of the sink-hole from the northern side.*

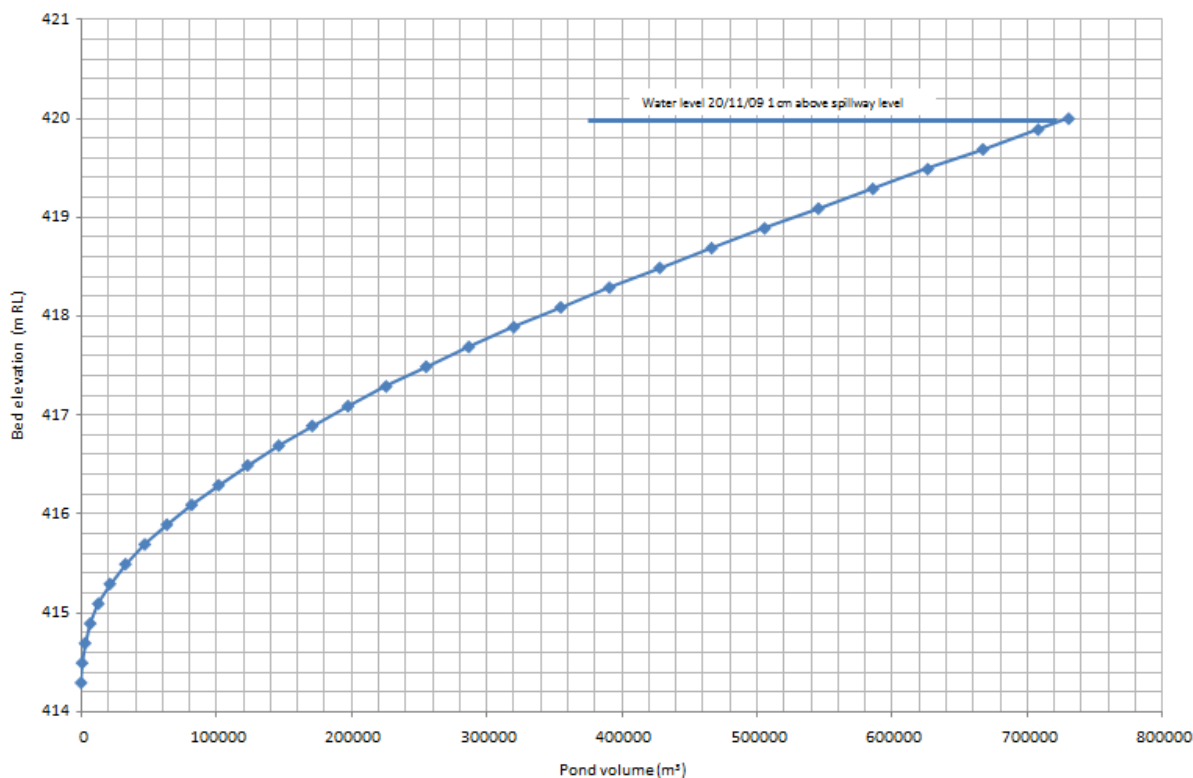
The quantity of water stored within the Tailings Dam reservoir beneath the level of the service spillway is approximately 730,000 m³ at up to 5.5 m depth¹⁴ (Graph 1 and Figure 5 in Appendix A). This was determined by measuring the depth below water level where a heavy plate was just supported by the tailings. These soundings were carried out from a boat in November 2009 and GPS readings were taken for each sounding. Given the capacity of the spillway system, the recent apparent lack of rapid response of the landslide to rainfall and the assessed “least unlikely” failure mechanism, we consider that it is reasonable to assume that the reservoir level would be about RL 420 m at the time of a (highly unlikely) dam failure.

Graph 1. Tailings Dam storage-elevation curve as measured in November 2009

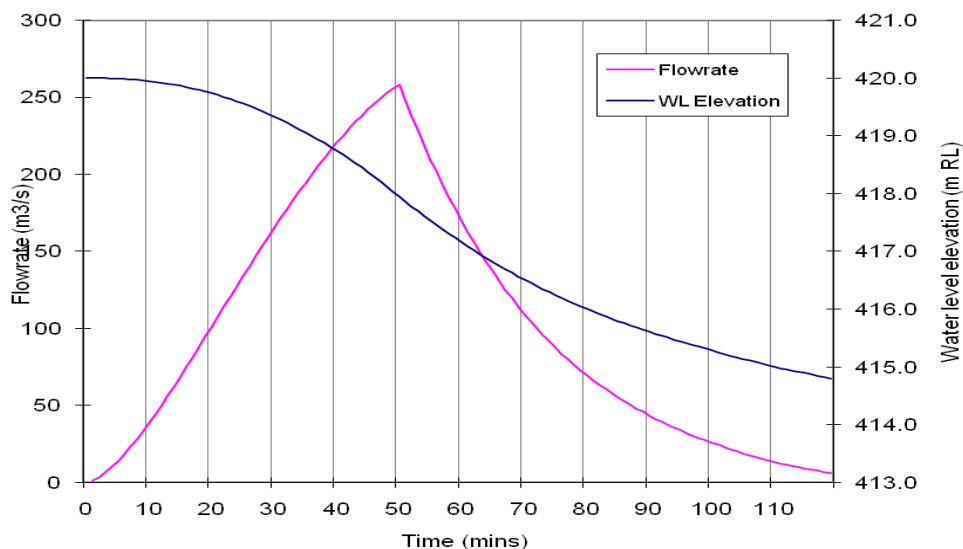
A peak dam discharge of approximately 260 m³/s has been calculated for this breach scenario using a spreadsheet based on the storage-elevation curve of the reservoir and a broad-crested weir discharge relationship (Graph 2).

Graph 2. Computed dam break hydrograph resulting from 20 m wide breach developing over 50 minutes

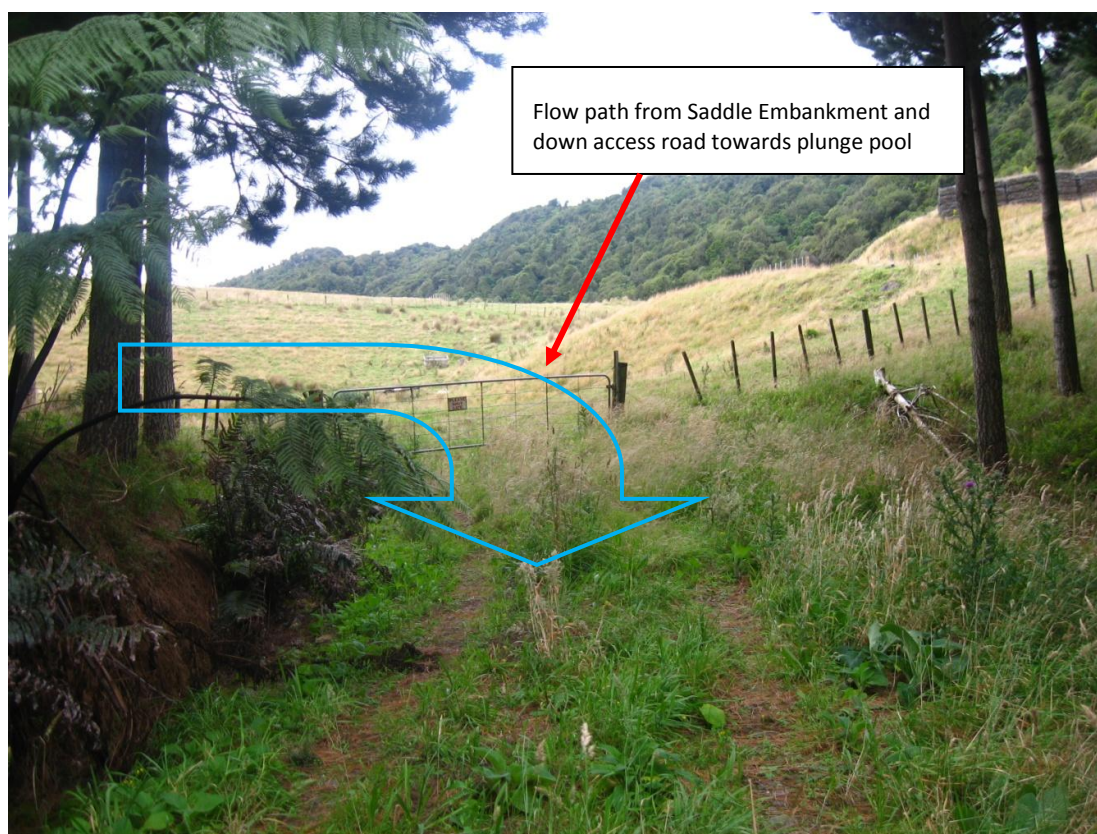
Photograph 2. Looking up along potential dam breach flood path towards Saddle Embankment (breach to left of photograph)

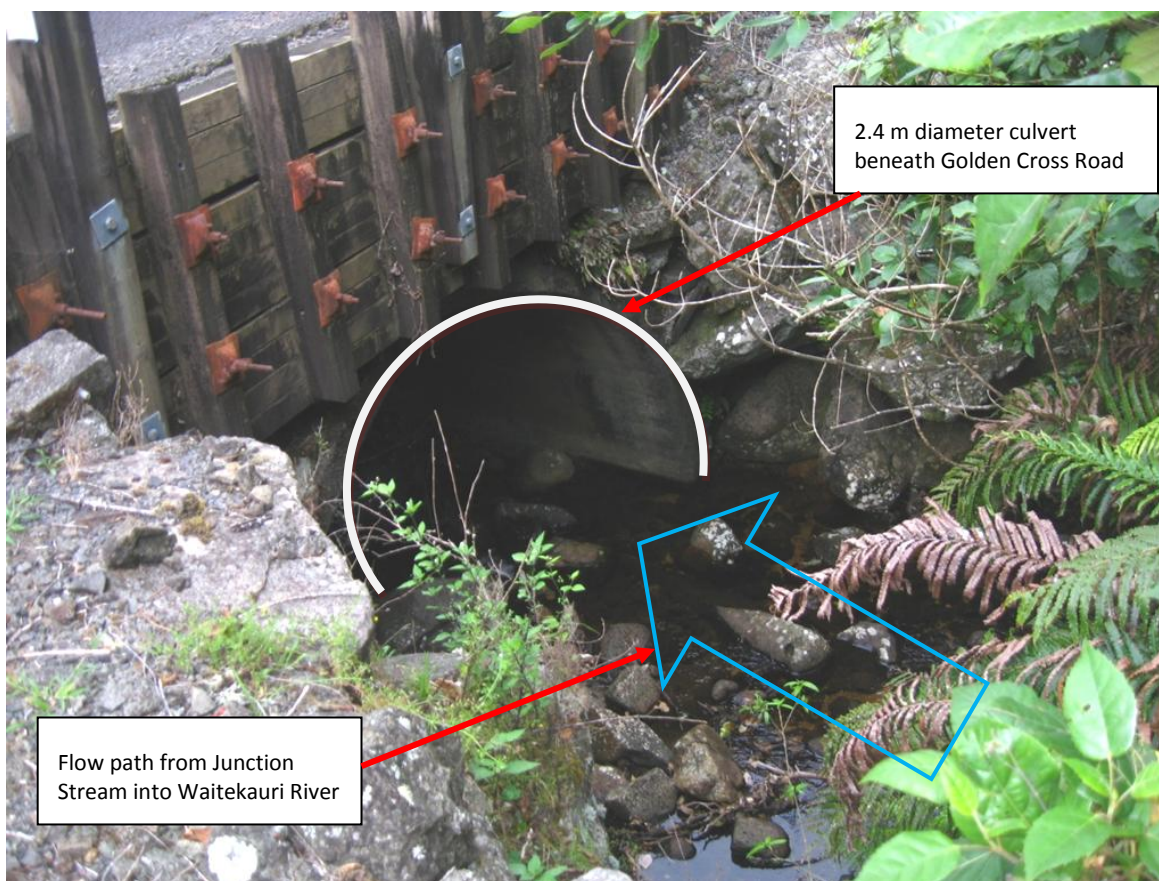
Because the calculated unattenuated peak tailings dam discharge is similar (less than 10% difference) to the 1 in 100 year flow in the downstream reaches of the Waitekauri River, we consider that no more than minor damage would occur to the SH2 and Campbell Road bridges if these structures had been designed for a 1 in 100 year event (we have not verified the design standards for the bridges). However, we consider that the two smaller bridge and culvert crossings on Golden Cross Road, beginning at the confluence of the Junction Stream (Photograph 4) and Waitekauri River, are likely to experience significant damage in the event of a dam failure. Erosion of the Waitekauri River channel may also result in localised washouts affecting the Golden Cross Road where the channel is close to the road.

Photograph 4. 2.4 m diameter culvert beneath Golden Cross Road through which the Junction Stream discharges into the Waitekauri River

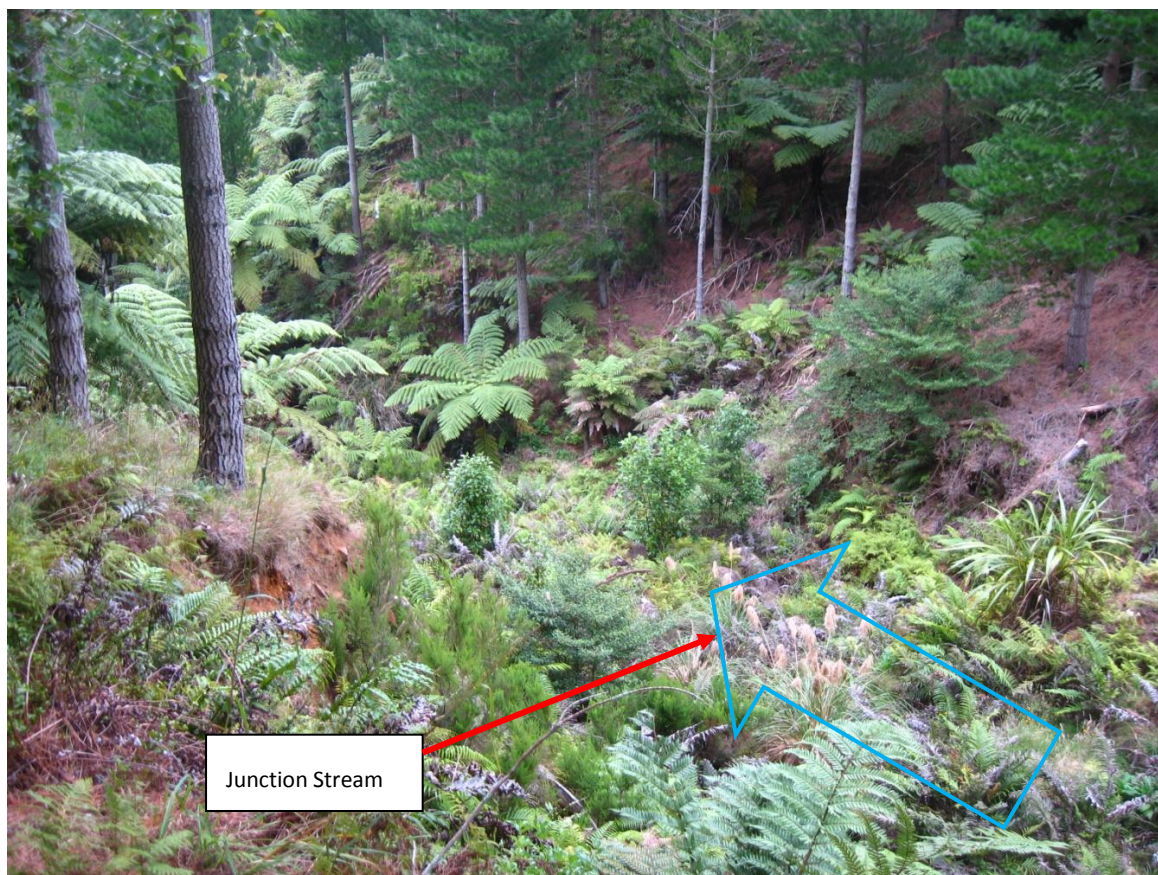
Some erosion/scour damage to the Junction Stream and the upper reaches of the Waitekauri River could also be expected, although the Waitekauri River channel is relatively stable with large-sized boulders (up to 2.5 m diameter) lining the bed and banks. We have not quantified the amount of erosion damage that may occur, although we note that the high flow volumes/rates would be partially offset by the short duration of any dam break discharge. It is noteworthy that significant erosion damage within the Junction Stream channel shown on an aerial photograph taken in February 1998 shortly after Cyclone Fergus is not visible in an aerial photograph taken in 2007 and, indeed, significant vegetation growth (grass and pine trees) has occurred adjacent to the stream up to the present day (Photograph 5).

Photograph 5. Typical Junction Stream valley (rocky stream not visible in base of valley due to vegetation growth)

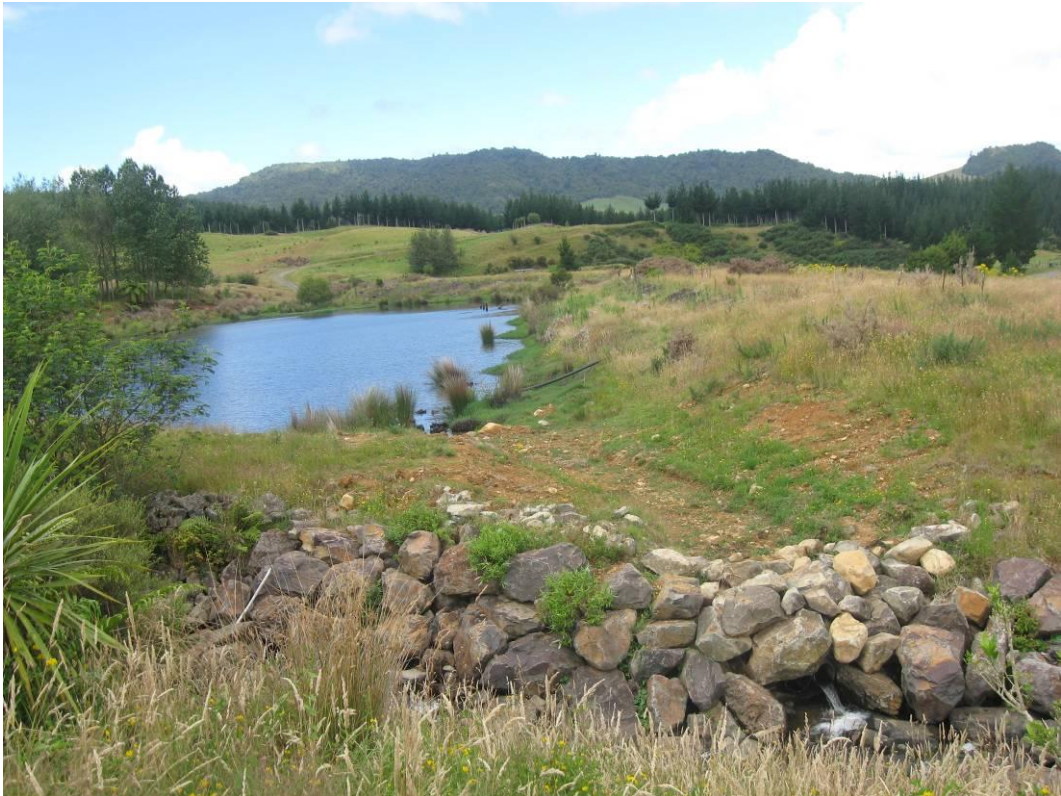
At the time of the survey, the water level in the pond was controlled by a discharge pipe approximately 0.5 m below the spillway crest. Typical details are shown in Photographs 6 and 7. Subsequent to the survey being undertaken, the discharge pipe and spillway were lowered by approximately 0.55 m – i.e. the November 2009 water level was approximately equal to the level of the current spillway. The new operating water level is at approximately RL 282.0 m and the new spillway crest is at approximately RL 282.5 m giving the dam impoundment a maximum water depth of about 2.3 m and a water volume of approximately 12,000 m³.

Photograph 6. Lowered USD overland spillway (pipe discharge approximately 0.5 m below spillway level)

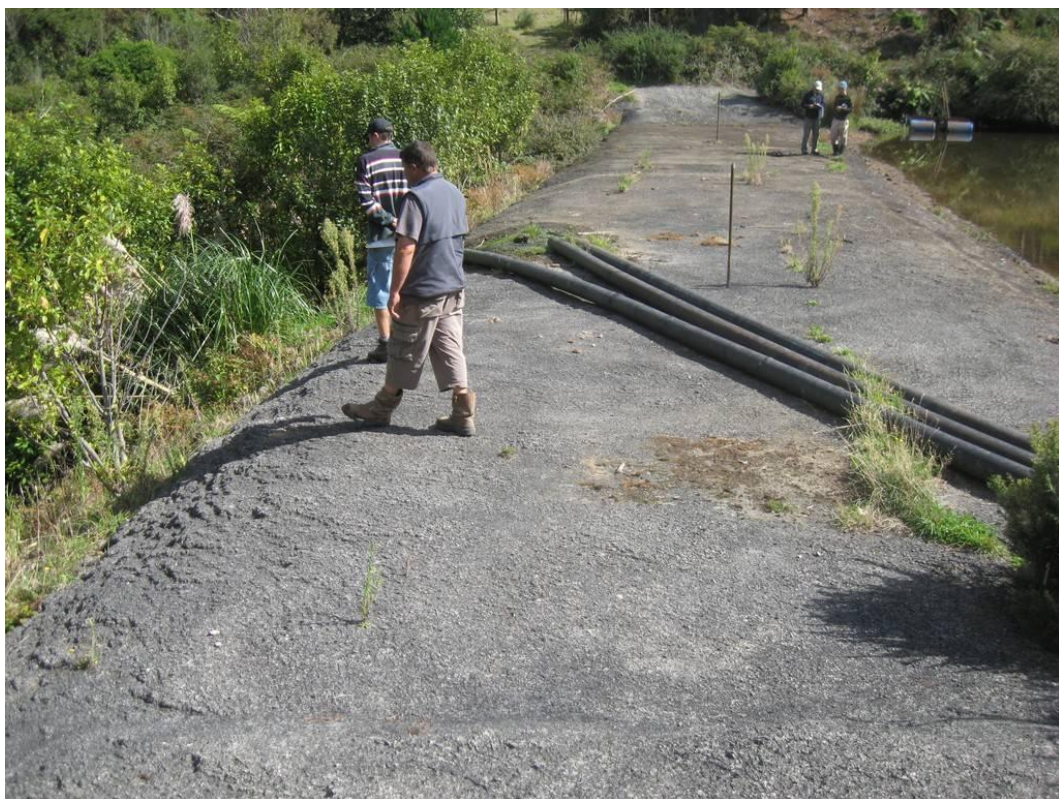
The water level in the pond is controlled by a spillway discharge over the shotcrete lined embankment crest (Photograph 8). At this level the dam impoundment has a maximum water depth of about 3.5 m and a water volume of approximately 9,500 m³.

Photograph 8. SYSD crest/spillway looking from left abutment, with low point in crest at the far end

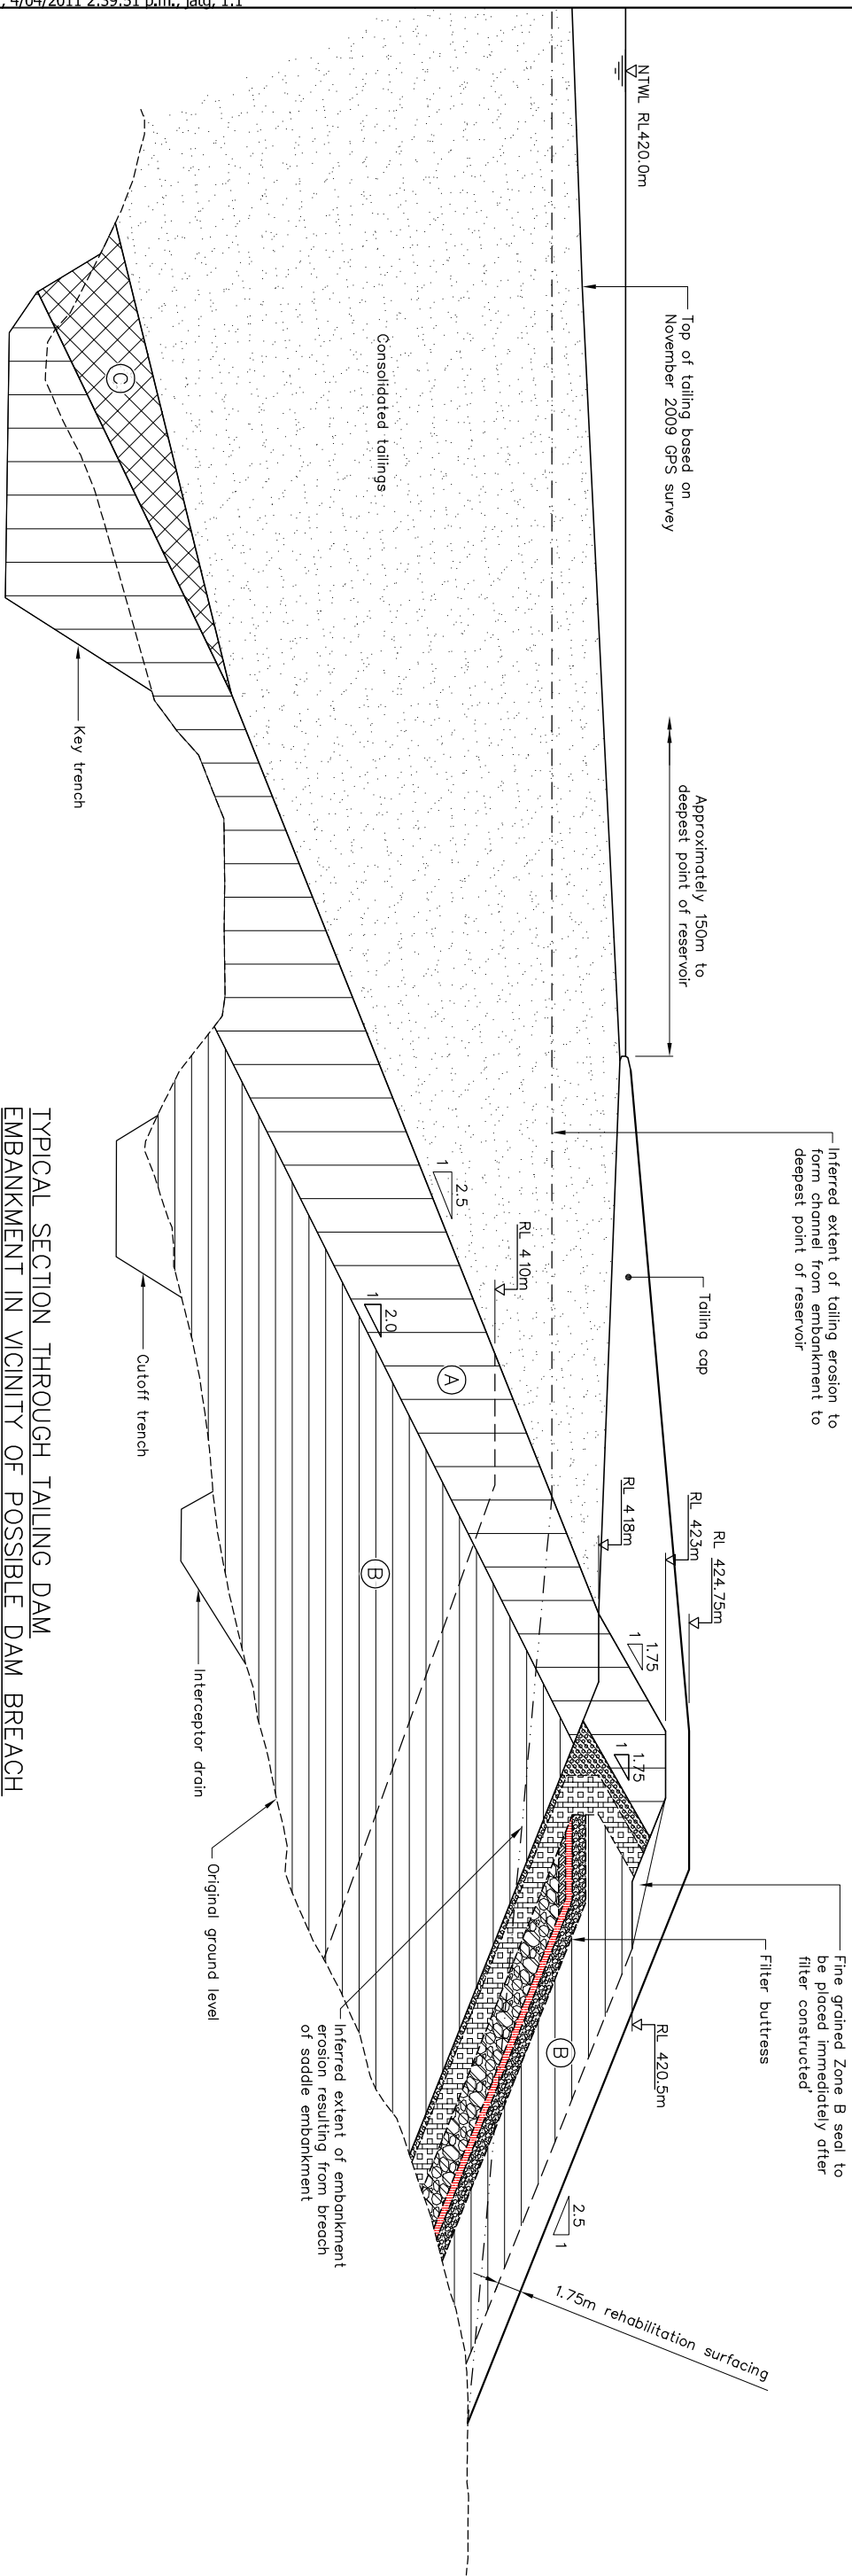
| COEUR D'ALENE MINES CORPORATION GOLDEN CROSS TAILINGS DAM Saddle Embankment Cross Section | | FIG. No. Figure 4 | | |

TYPICAL SECTION THROUGH TAILING DAM
EMBANKMENT IN VICINITY OF POSSIBLE DAM BREACH
SCALE 1:500

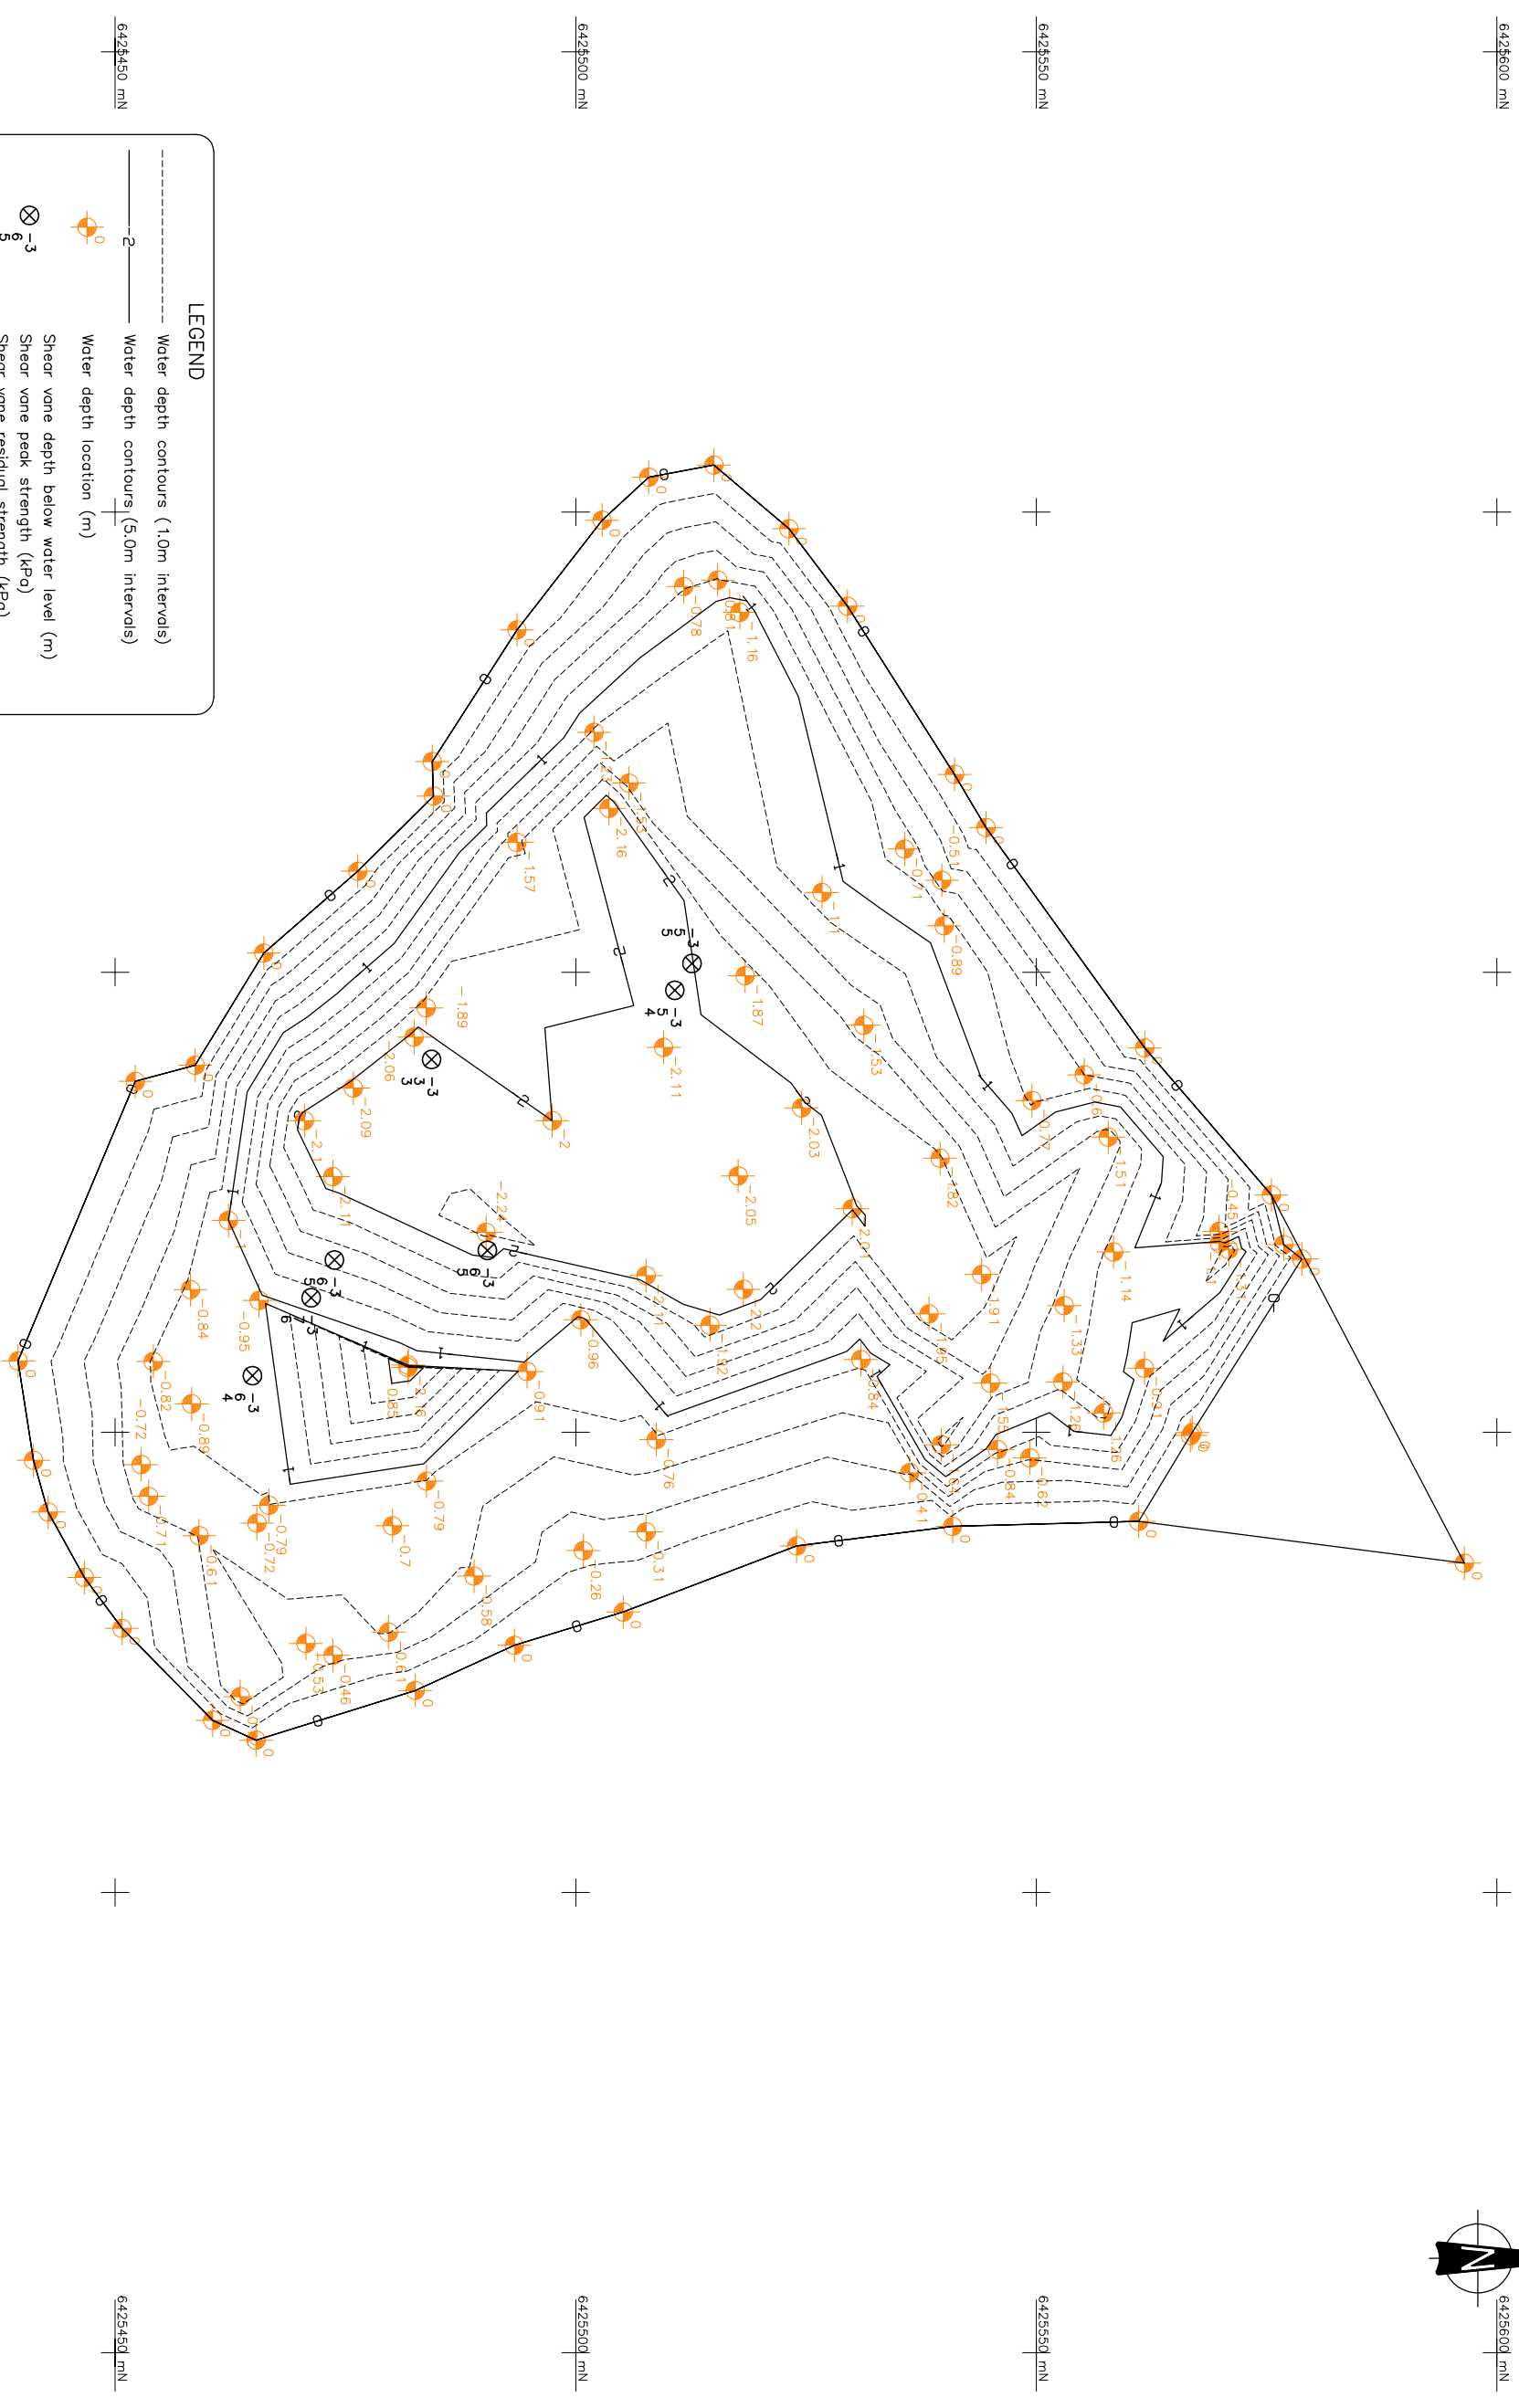
| | PROJECT No. 613625.001 | | FIG. No. Figure 6 |

The USD is located approximately 900 m south west of the Tailings Dam, across the road from the Water Treatment Plant. As with the Tailings Dam, depth soundings were undertaken in November 2009 to determine the volume of the pond. A contour plan is attached as Figure 6 in Appendix A and a storage-elevation curve is shown in Graph 3 below.
